On-site Monitoring Surveys and Investigations of Subsurface Cavity for Effective Road Cave-in Prevention

Keywords: road cave-in, cavity, sandy ground, radar exploration, sewer pipe

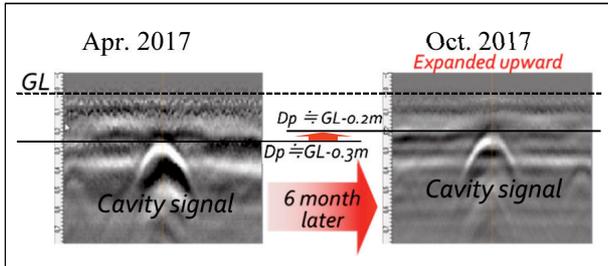
As shown in Table 2, the No.13 cavity expanded upward in just 6 months. This phenomenon was confirmed by the change in the cavity signal in GPR as shown in Fig 8. This cavity was confirmed to expand upward but not horizontally.

Figure 8. Cavity signal of GPR data of expanded cavity: No.15

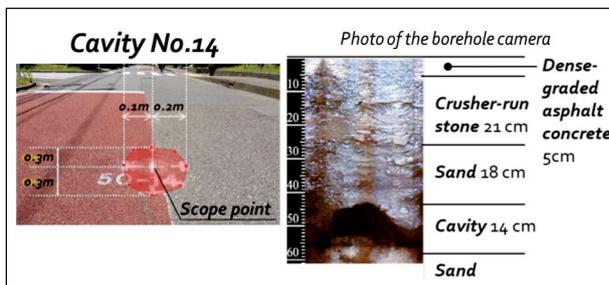
At the cavity of No.14, the monitoring survey of the inside condition of the cavity was conducted 4 times in 2 years. In the investigations, the scoping survey with a borehole camera was inserted into the cavity to measure the cavity thickness as shown in Fig. 9 and observe the internal condition as shown in Fig. 10. As shown in the below figures, the No. 14 cavity was formed within the subgrade of the sandy soil layer, and the upper part of the cavity was an arch.

Figure 9. Location photo and photo of the borehole camera of the cavity of No.14.

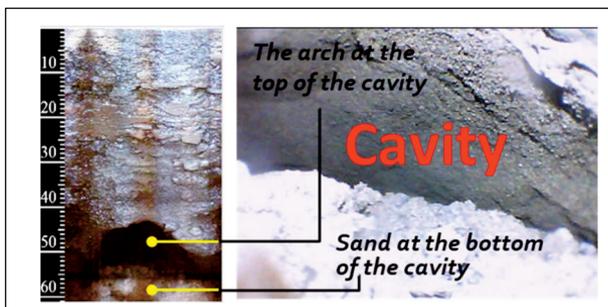
Figure 10. Photo of the internal condition of the cavity of No.14.

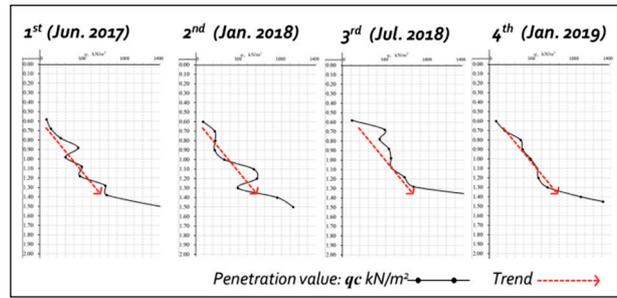
After scoping surveys, the portable cone penetration tests were conducted every time to understand the looseness under the cavity. Fig.11 shows the results of 4 portable cone penetration tests, but all showed the same trend, and no significant changes were observed. Table 3 shows the thickness of the cavity and the thickness of the loosen layer below the cavity in the four surveys.

Figure 11. Results of 4 times the portable cone penetration tests below the No.14 cavity.

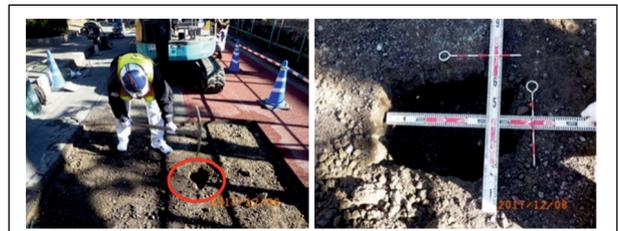
Fig. 12 shows the appearance of the cavity in the crushed stone layer just under asphalt and the size measured on-site (70cm x 70cm).

Figure 12. Photos of No.13 cavity formation.

With these actual conditions, it was presumed that the soil around the sewer pipe flowed out with groundwater, and then this cavity formed. It was a small gap in the joint of the pipe that the soil flowed. After this investigation, the cavity was restored with the shoulder of the sewer pipe was cured with mortar.

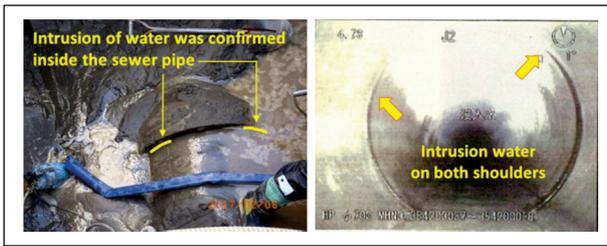
When the sandy ground under the cavity was dug down, groundwater appeared at GL-1.45m, and the joint of sewerage (HP, ϕ 800) appeared at GL-1.64m in the groundwater. This sewer pipe was built in 1969, but there was no damage on the outside. Therefore, as a re-

sult of an internal camera survey of sewer pipe, intrusion water was found on both shoulders (Fig. 13).

Figure 13. The sewer pipe joint in groundwater (left) and intrusion water confirmed in the sewer pipe (right).

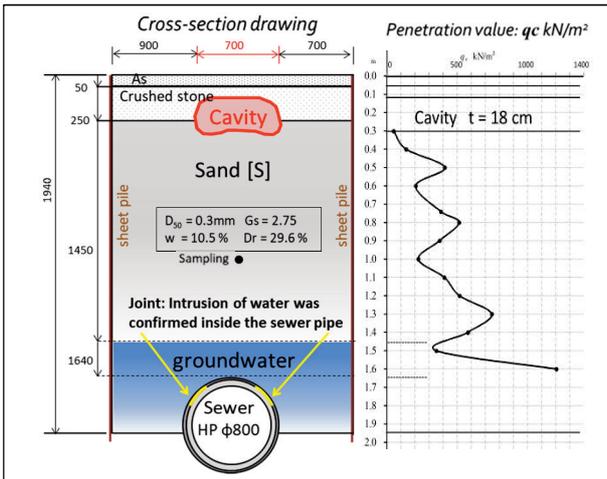
Figure 14. Cross-section drawing showing the condition of the No.13 cavity occurrence and the penetration value of below the cavity.

Fig.14 shows the condition of the No.13 cavity occurrence by the cross-section drawing and the penetration value of the cavity. Below the cavity was a loose sand layer to the groundwater surface. A result of soil test of sample at a depth of 1m was that $D_{50} = 0.3\text{mm}$, $G_s = 2.75$, water content = 10.5%, relative density = 29.6%.

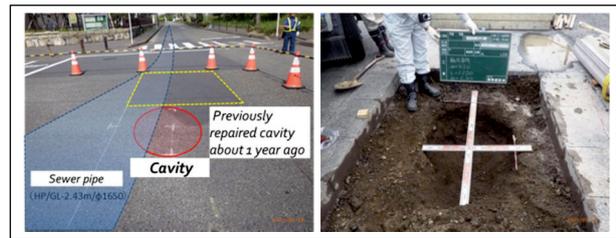
The size of this cavity is; depth = 0.2m, thickness = 43cm, length = 1.3m, and width = 0.9m. This case is also a cavity that was urgently repaired in sandy ground. In the 1st monitoring survey, this new, large, shallow cavity was explored, so it was urgently repaired based on the judgment that the risk of cave-in was high, and a detailed investigation was conducted at the same time. This investigation and repair took two days. Fig. 15 shows the location of the cavity before open-cut and the previously repaired cavity that close to the sewer pipe. Besides, the cavity was observed to be in the sand with gravel after being open cut.

Figure 15. The location of the cavity and the cavity in the sand with gravel.

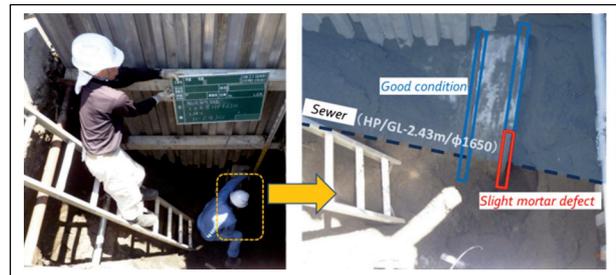
Under the cavity and sand with gravel ground, the joint of sewerage (HP, $\phi 1650$) appeared at GL-2.43m in the parched and loose sand. This sewer pipe was built in 1966. When examining the joint part, it was confirmed that there was a slight lack of mortar as the finger could insert a little (Fig. 16).

Figure 16. The joint of sewer pipe under the cavity.

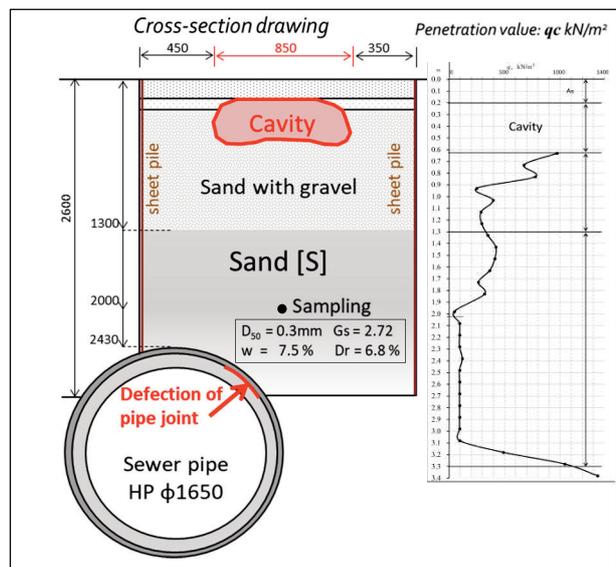
Fig.17 shows the condition of the cavity occurrence by the cross-section drawing and the penetration value of the cavity. Below the cavity, there was a layer of sand with gravel and loose sand layer. As a result of soil test of sample at a depth of 2m, $D_{50} = 0.3\text{mm}$, $G_s = 2.72$, water content = 7.5%, relative density = 6.3%.

The penetration value and very small relative density values showed that the sand layer under the cavity was very loose. That is the characteristic of this cavity occurrence. From these investigation results, it became clear that a tiny gap makes the loosening of the sand layer of 1m or more, and a cavity formed in a short period above it.

Figure 17. Cross-section drawing showing the condition of the cavity occurrence and the penetration value of below the cavity.

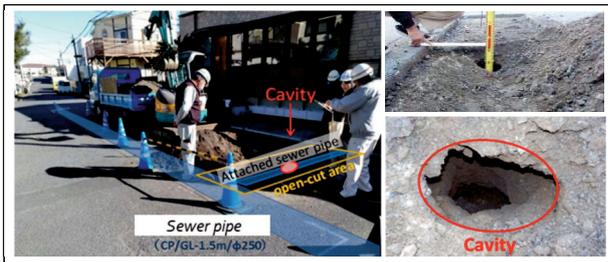
As revealed by excavation, this cavity was thick and expanded upwards in a short period and occurred at the place where the buried utilities were congested. The size of this cavity is; depth = 0.15m, thickness = 50cm, length = 0.3m, and width = 0.4m. This case is also a cavity that was urgently repaired in sandy ground. In the 2nd monitoring survey, this new, shallow cavity was explored, so it was urgently repaired, and a detailed investigation was conducted at the same time. Fig. 18 shows the location of the cavity before excavation, that close to the attached sewer pipe.

Figure 18. The location of the cavity and cavity formation.

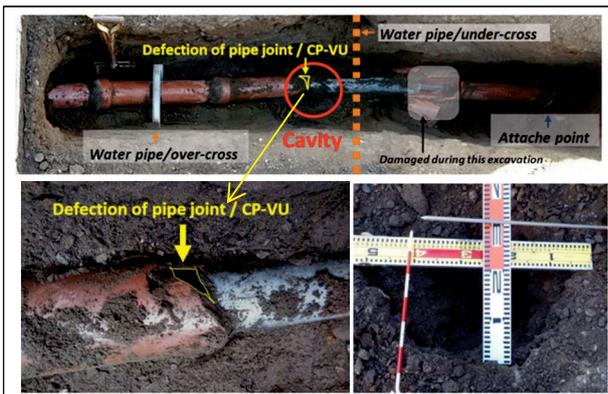
As shown in Fig. 19, just 20cm below the cavity, there was a ceramic sewer attachment pipe partly replaced with a PV pipe and a water pipe crossing under there. In addition, there was a small deflection at its connection point of the pipes. From these facts, it is considered that the cavity formed by backfilling soil flowing out from the deflection point. Moreover, it is thought that the construction work of a crossing water pipe under the attachment pipe broke the attachment pipe and replaced it.

Figure 19. Picture of the deflection of the pipe joint and the cavity.

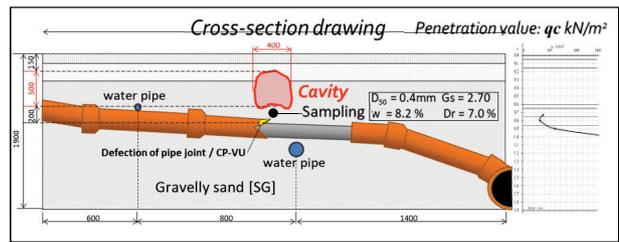
Fig.20 shows the condition of the cavity occurrence by the cross-section drawing and the penetration value of the cavity. Below the cavity, there was the replaced pipe in the sand layer. The result of soil test of sample at a depth of 0.7 m was that $D_{50} = 0.4\text{mm}$, $G_s = 2.70$, water content = 8.2%, relative density = 7.0 %.

The penetration value and very small relative density values showed that below the cavity was very loose. Besides, the penetration resistance was large, and there was no looseness below the deflection point. From these investigation results, it became clear that even a small

gap created artificially could cause a cavity, and a cavity is formed in a short period above it.

Figure 20. Cross-section drawing showing the condition of the cavity occurrence and the penetration value of below the cavity.

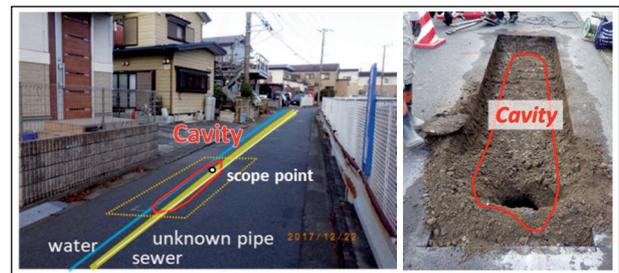
Fig. 21 shows the location, the shape of the cavity as long in the longitudinal direction, and the cavity was very shallow. Besides, there were some utilities around the cavity. The size of this cavity is; depth = 0.2m, thickness = 50-60cm, length = 3.2m, and width = 0.4m.

Figure 21. The location of the cavity.

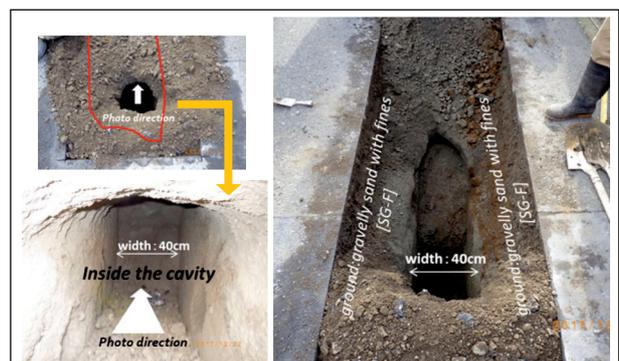
Figure 22. Picture showing the cavity formed in the ground non-flow-ability soil as of natural ground.

Fig. 22 shows that this cavity was formed in the ground non-flow-ability soil as of natural ground. The two photos on the left are the internal conditions of the cavity taken with the camera in the wellhead before excavating. There was “a space like an artificial waterway.” The cross-sectional shape of the cavity was an artificial square. Inside the cavity, the self-standing sidewall extended straight in the longitudinal direction of the road. The right side photo shows that the sidewall of the cavity did not collapse at all even, and it remained independent. When digging the loosen sand under the cavity, a water pipe and a sewer pipe were confirmed at a depth of 1.1-1.3m. Regarding the sand around the cavity, it was different from the natural ground as sidewall, and it would be considered that the backfilling when those pipes were constructed.

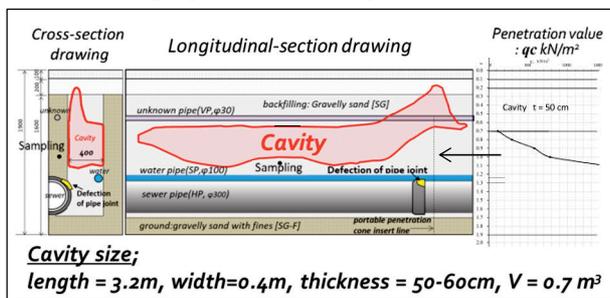
Fig.23 shows the condition of the cavity occurrence by the cross-section drawing, longitudinal-section drawing, and the penetration value of the cavity. The cavity was formed like an artificial waterway because only backfill material on the pipes flowed without erosion of the ground—besides, the penetration resistance value in-creased in proportion to the depth.

Figure 23. Cross-section drawing showing the condition of the cavity occurrence and the penetration value of below the cavity.

The condition around the cavity is as follows the self-standing ground is an artificial shape of 40cm width, the backfill material is sand, and the damaged part of the sewer pipe joint that caused the void protruded slightly from the natural ground. The joint was seemed to be damaged by excavation work. For repair of there, the damaged part was covered with mortar, but the pipeline was not replaced. The capped mortar lost adhesive strength due to ageing and the environmental condition, and the gap occurred. This gap was getting more extensive; it became a path for around sand to flow out; thus, the cavity formed.

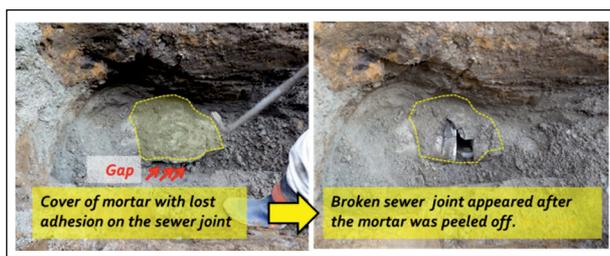
Fig.24 shows the detail condition of the deteriorated mortar. There was floating the cover mortar. When it was peeled off, a broken sewer pipe appeared.

Figure 24. Photo of the cause of the cavity as the gap by mortar deterioration covering sewer pipe joint breakage.
