Qualitative analysis by local ground water level observations and seepage analysis of underseepage during flood at the Kita river

ABSTRACT: At the Kita River, which flows through Kyushu, Japan, there have been three major floods between 2016 and 2018 that significantly exceeded the height of the ground level. Each time, large-scale sand boils due to underseepage have been confirmed at around 13.0 km on the left bank. The base ground has a very thick permeable layer of gravel. Also, a sand layer (thickness of about 2m) has been distributed near the surface of the ground. Given this, the following mechanism may be in operation. While river water has penetrated into the permeable layer, it has been pressurized by the presence of the sand layer near the surface. It is assumed that the pressurized water has broken up the sand layer locally, causing an outflow at high velocity, which has ejected a large amount of sand. After the 2016 flood, an impervious sheet pile wall had been installed. While the effectiveness of the wall was confirmed in some places. But in other hands, there were some places where seepage and boils still occurred at floods after installing the wall. Ground water le

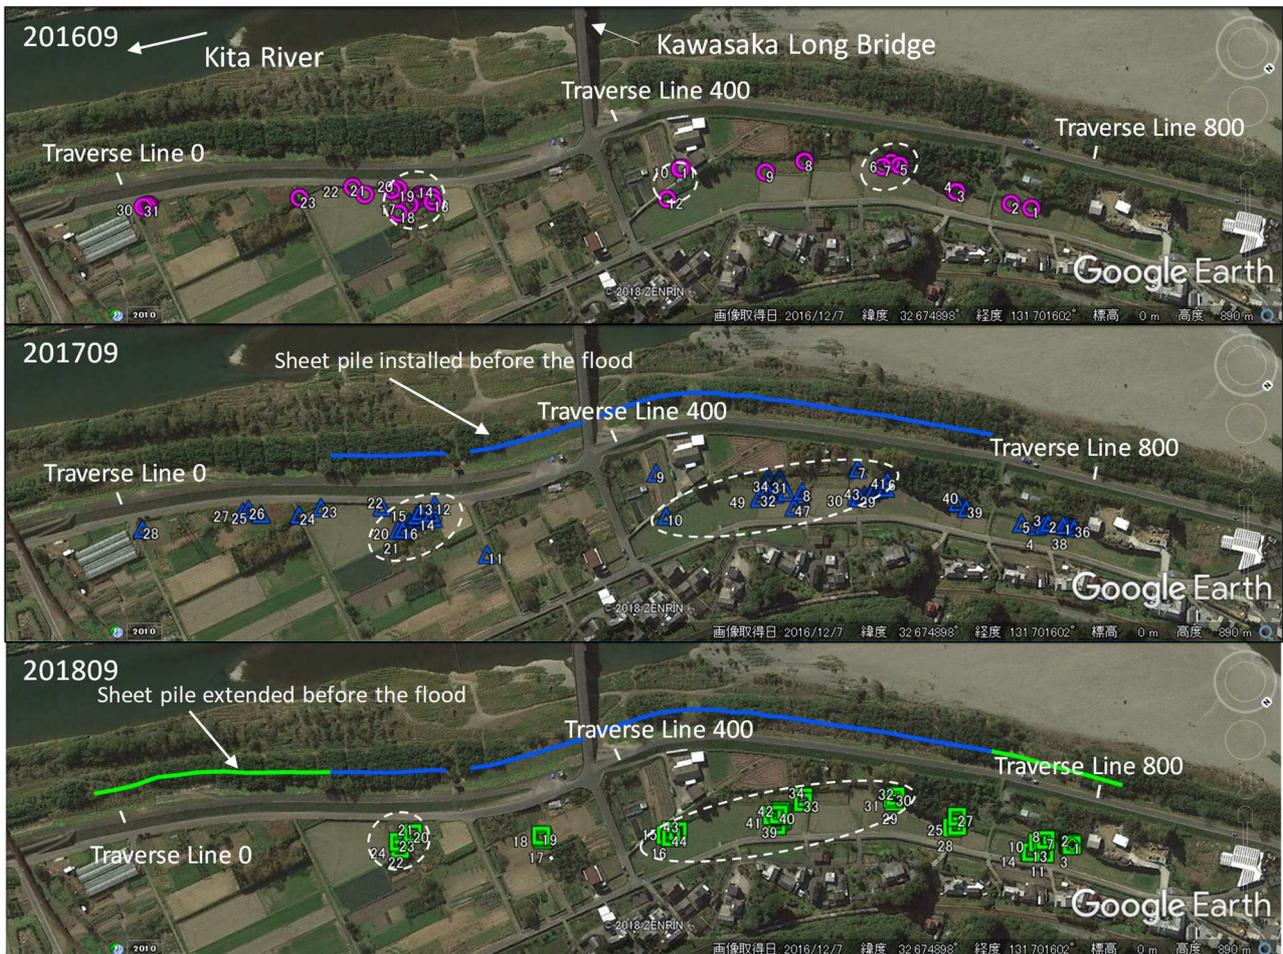
Fig. 4. shows the transition in seepage and sand boiling locations due to these floods. Compared to 2016, the number of leakage points from the 2017 and 2018 floods increased to around 400-600 side lines[1].

Figure 4. Changes in Water Leakage and Sand Boiling Locations (Area enclosed by broken lines includes major sand boiling and subsidence, with minor water leakage and sand boiling in other areas) from 2016 to 2018 and Range of Measures using Steel Sheet Piles[1]

Two factors can be considered for such a change. One is the difference in the highest flood water levels. It is possible that the leakage locations around 400-600 side lines occur due to higher water levels. The second factor is the effect of impervious sheet piles. After the 2016 flood, the installation of impervious sheet piles commences as a means of mitigating the impact on embankments of seepage and sand boiling. Residents near the leakage points have suggested that the reduced water leakage is a testament to the installation of the impervious sheet piles. This can also be considered the case due to the fact that traces of water leakage were only found

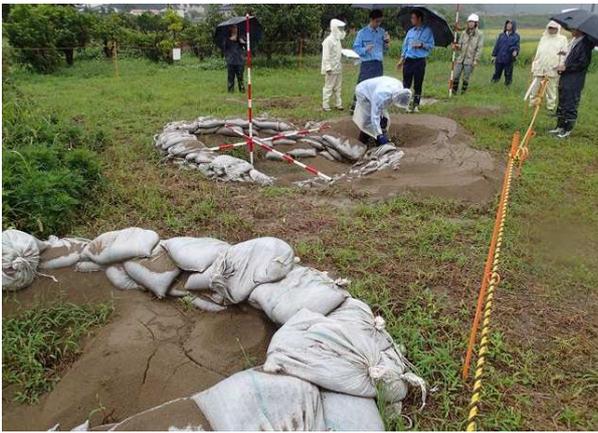
Figure 5. Traces of seepage and sand boiling 1

Large-scale traces of water leakage and sand boiling are shown in Fig. 5. and 6. Seepage and sand boiling locations were confirmed in several places where the accumulated sand spanned several meters in diameter. There were also many places where sand boiling was adjacent to subsidence. In the nearest cases, this type of seepage and sand boiling occurred in locations 10-20 m from the slope foot of the embankment.

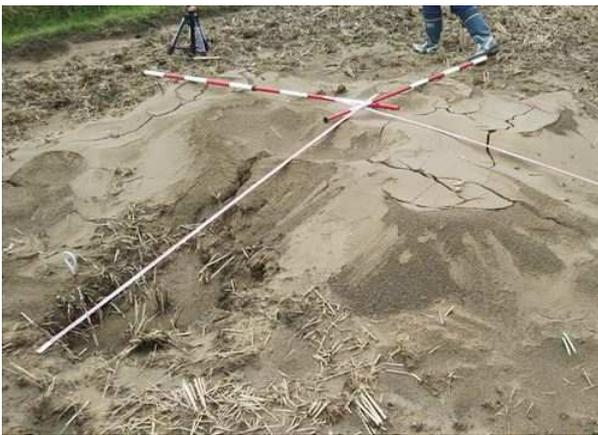
Figure 6. Traces of seepage and sand boiling 2

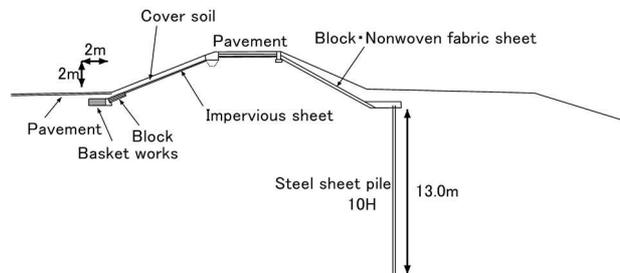
The embankments in this area had reinforcements for overtopping, like pavement at the top and impervious sheet at landside slope which are unusual in Japan. As mentioned above, impervious sheet piles have been installed and extended in this area since 2016. The result has been the embankment structure shown in Fig. 7.

Figure 7. Embankment structure

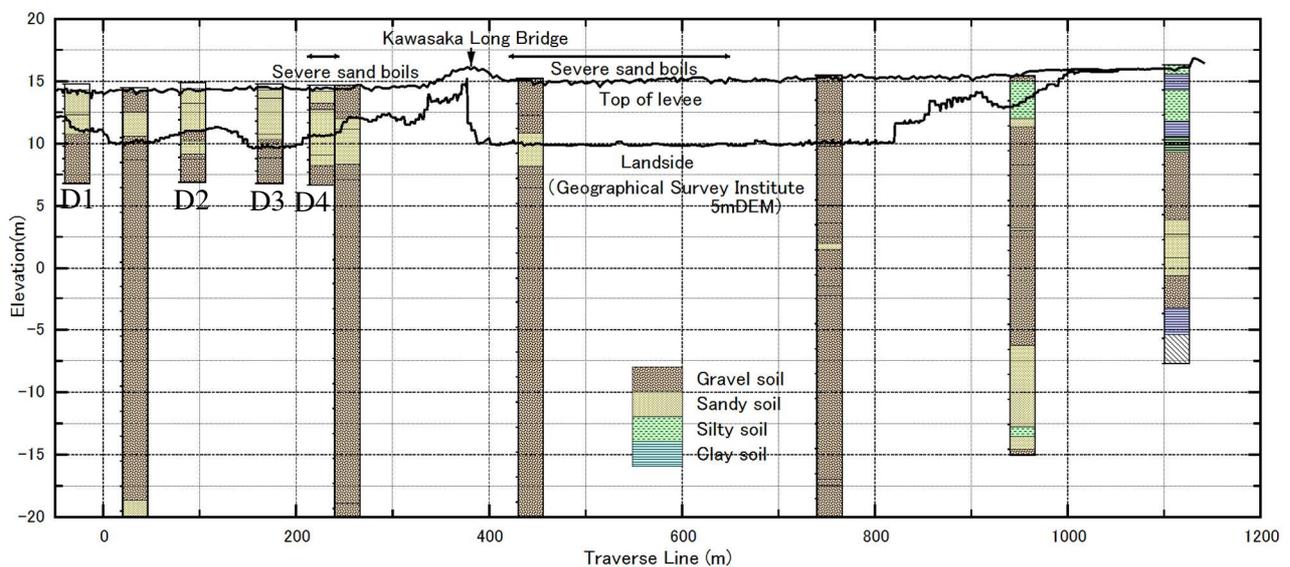
Fig. 8. shows the geological profile of the base ground structure. A thick gravel layer is distributed on the base ground widely. At its deepest points this gravel layer extends to about 50 m, and so the above-mentioned impervious sheet piles cannot completely cover the gravel layer. This is the reason why there have still be seepage and sand boils in spite of the laying of impervious sheet piles. It has been a feature of ranges of intense water leakage and sand boiling that there has been a 2-3m layer of sand distributed near the surface of the levees. According to an

Figure 8. Geological profile

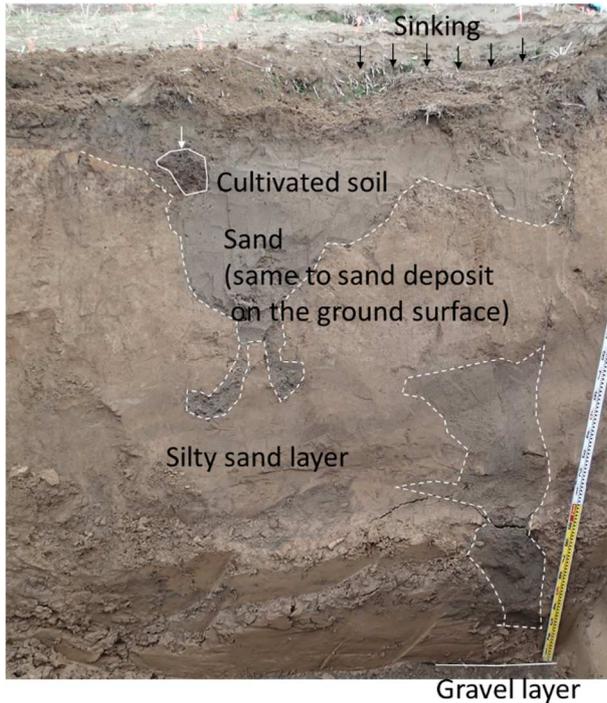
excavation survey of the location of sand boils shown in Fig. 9., because this sand layer included a lot of fine silt mixed in it is thought to have resulted in seepage as the water leaks from vein erosion. Sand that accumulates on the surface of the earth is assumed to be in the gravel layer, between the gravel.

Figure 9. Base ground structure at sand boil observed in excavation survey

Seepage and sand boiling are thought to occur due to rising water pressure in base ground gravel layers from rising river water levels. However, where serious seepage and sand boiling have been confirmed, sand layers have been observed at a height near the surface of ground levels. This is assumed to make it more difficult for the water pressure within the gravel layer to dissipate to the ground surface because of the sand layer above the gravel layer, which is estimated to make the water pressure rise. Furthermore, the occurrence of seepage and sand boiling breaking through local sand layers, is considered to be the cause of large flow rates and the accumulation of large amounts of sand.
