# Investigation on Slope Failures Caused by the 2018 Northern Kyushu Torrential Rainfall, Japan

**ABSTRACT:** During June 28 to July 8, 2018 torrential rainfalls in most parts of Japan caused many slope failures and debris flows. In order to protect the lives and properties of residents from disastrous slope disasters, it is necessary to evaluate the risk of slope failures and to clarify the mechanism of failures to arrive at efficient and effective disaster prevention measures. This study covers the slopes that failed in Kitakyushu city, that composed of complex geological structures, during the July 2018 western Japan torrential rainfall. Through detailed investigations of the topography and geological conditions, the cause of such slope failures was ascertained. The investigations were conducted using both the topographical observation and UAV survey. Based on the investigation results, the mechanism of the slope failure was elucidated, and design procedures for the recovery countermeasures were arrived at.

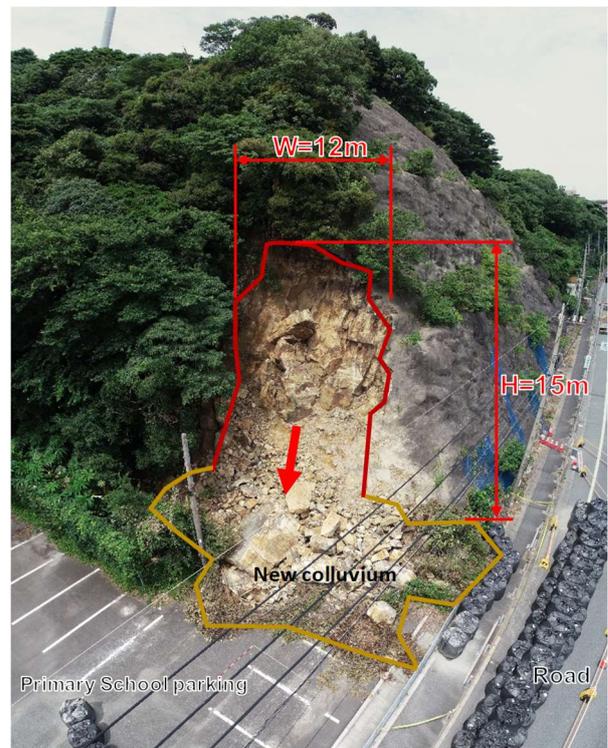
The slope failure occurred around 20:00 on July 5. The slope failure scale is 15m in height, 12m in width, 2m in average slope failure depth, 360m<sup>3</sup> in slope failed soil volume (all approximate) ( Fig. 6).

The slope failure partly reached the road, but because it was mainly directed to the adjacent primary school parking lot side, it did not cause major damage.

The geology of the slope is equivalent to the Orio sandstone of the Paleogene Ashiya Group, and is composed of massive sandstone with cracks. Although the weathering of the rock is weak, the cracks are square and open. No spring water was seen from the slope failure surface. An unstable rock mass remains on the slope failure surface, and an overhanging rock mass is seen at the slope failure head. Even after several hours of slope failure, small rockfalls (about the size of a human head) have occurred, and there is a possibility of expansion. On the slope of the road side, there was no expansion of deformation that was a sign of slope failure.

Figure 6. Bird's eye view of the collapsed slope

In the Mizumaki area, it was necessary to remove the collapsed sediment that had reached the road as soon as possible. The slope was steep and many unstable rock blocks were seen on the failure slope, making it difficult to approach for topographical survey. Topographic plan and cross-sections were created by aerial photogrammetry using UAV, and countermeasures were examined. It was judged that the slope stability countermeasure work requires a structure countermeasure because it is difficult to secure a stable slope by cutting (re-cutting is difficult) due to site restrictions.

In addition, as a result of UAV images and telescopic observation, it was confirmed that an unstable soil mass (failure residue) remained above the failure site. Therefore, a reinforcing bar insertion work was adopted as a measure for stabilizing the remaining block. In addition, the wire net work will be installed for the purpose of integration by connecting the heads of the reinforcing bar inserts to ensure stability and to prevent the falling of small pieces of unstable soil blocks.

On the other hand, since many cracks develop in the lower part of the collapsed part, it was decided to stabilize by grating crib work.

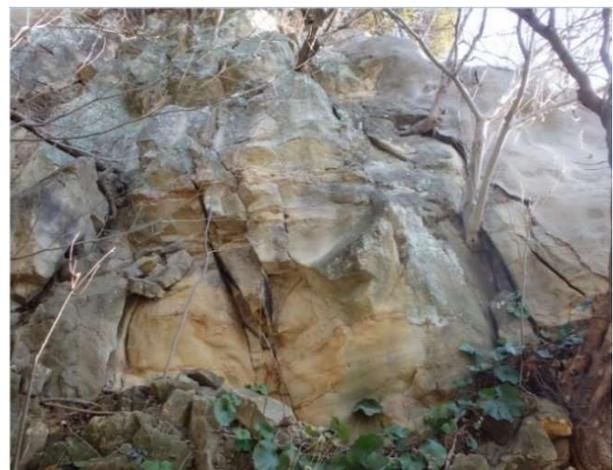
The slope failure part is continuous with the cut slope of the main line. Before the slope failure, part of it was protected by a mortar sprayer, forming a steep cliff near the vertical and exposing the rock mass with many cracks (Fig. 7).

Figure 7. The outcrop of the slope before the collapse

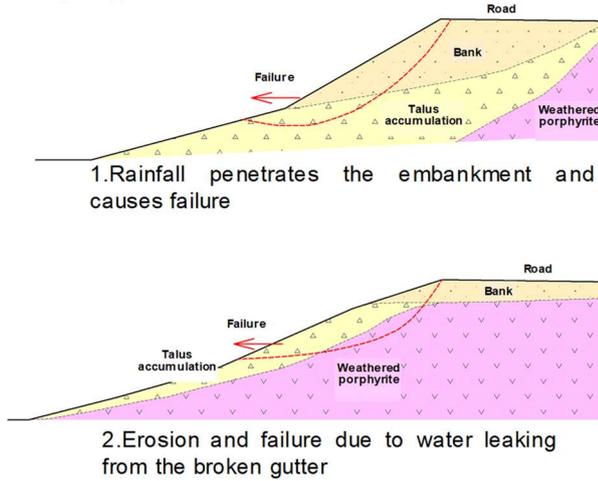
Based on the topographic and geological conditions of the slope, the failure mechanism is assumed as follows (Fig. 12).

1. Rain infiltration concentrated on the embankment filled with a small catchment topography, and when it saturated, the surrounding talus accumulation also involved and collapsed (collapse on the right side from the center of the collapse).

2. At that time, water leakage occurred due to the rupture of the shoulder-side gutter, and talus accumulation on the left side of the collapse, surface layer collapse of weathered porphyrite, and erosion occurred (collapse and erosion on the left side of the collapsed part).

Figure 12. Failure form and assumed geological section

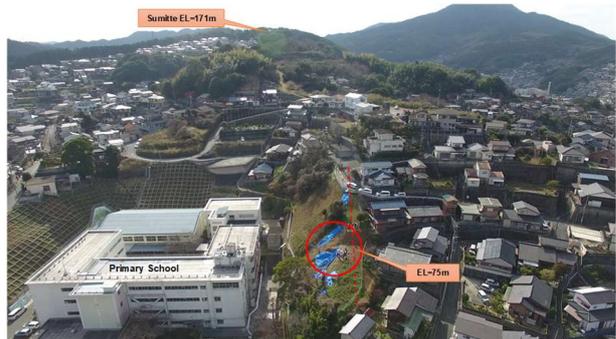
The slope failure occurred early morning on July 6. The scale of the failure is a cut slope with a height of 10m, a width of 20m, and a valley formed by the creation of the primary school.

Figure 14. Bird's eye view of the failure slope

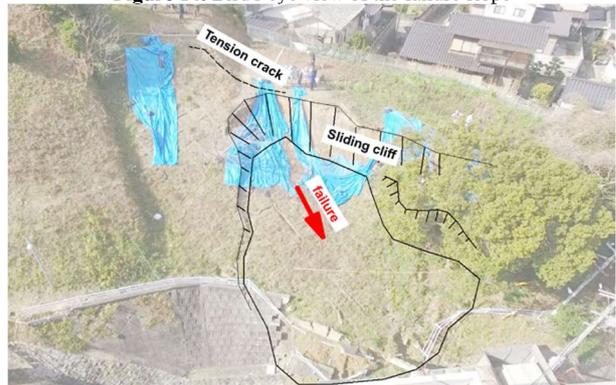
Fig. 13 shows the topographic map around the target site, Fig. 14 shows the aerial photograph, and Fig. 15 shows the photograph and sketch of the failure slope. The failure slope is located in a low mountainous area with small undulations where residential land development has progressed, and on a straight ridge topography. In the borehole survey, fresh rock mass has not been confirmed, and there is no outcrop nearby, so the relationship between geological structure and topography and failure is unknown. Since it is located on the east side of the ridge topography and surface water is not easily collected, it is thought that the influence of surface water on the collapse is small.

Figure 15. Photograph and sketch of the failure slope

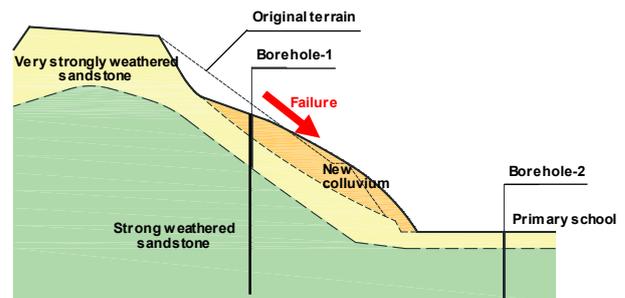
The geology of the failure slope is composed of strongly weathered sandstone corresponding to the Lower Cretaceous Kanmon Group and the Shimonoseki Group, and exhibits a reddish brown to yellow-gray sandy cohesive soil. As a result of the survey, weathering progressed at a thickness of 10 m or more (Fig. 16).

The failure mechanism is assumed as follows based on the geological condition of the slope (Fig. 16).

1. Saturation of the surface sediment increases due to heavy rain.

2. The weight of the surface soil increases, the strength constant decreases, and failure occurs.

Figure 16. Failure form and assumed geological section
