Application of CPT to investigation of abandoned shallow coal workings, and their remediation by grouting

ABSTRACT: CPT testing was carried out before and after the grouting of abandoned shallow coal mine workings to understand the conditions of the workings and to infer the extent of underground voids that were filled with grout during their remediation. The site, with 2-3m of coal extracted by bord and pillar workings from between 10 and 13m depth, has a recorded history of widespread surface subsidence and ongoing potholing over the more than 100 year period since mining ceased. Prior to grouting, from 3 CPTs and three drilled boreholes, there was no evidence of open voids, indicating that collapse of the workings was extensive. The CPT was found to be a poor differentiator of subsurface conditions in this instance, failing to clearly differentiate intact roof from subsided roof, or between subsided roof and goaf. Despite the phreatic surface lying only 4-6m below the surface, pore water pressure data was inconsistent, fluctuating unpredictably between positive and negative values. Generally, negative pore pressures were recorded at depths corresponding to the subsided roof and

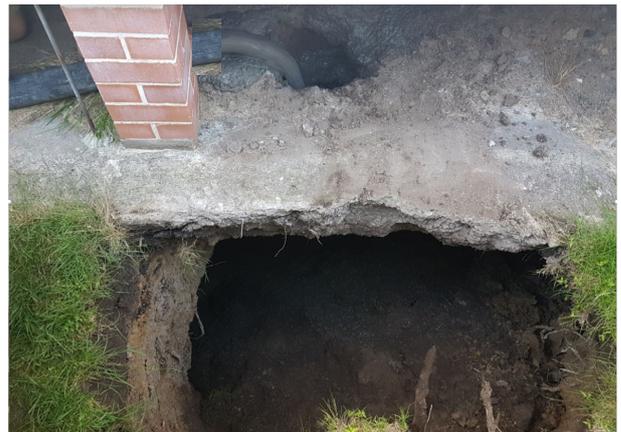
Figure 2. Typical surface expression of pothole subsidence of shallow mine workings, and filling with concrete.

A common way of remediating sites affected by shallow mine subsidence is to emplace under pressure a flyash/cement grout mixture directly into the mine workings from the surface to limit any further collapse or consolidation of the rubble. The flyash used is derived from coal-fired power generation, and the target strength of the grout produced is between 1 and 4 MPa, usually closer to 1MPa.

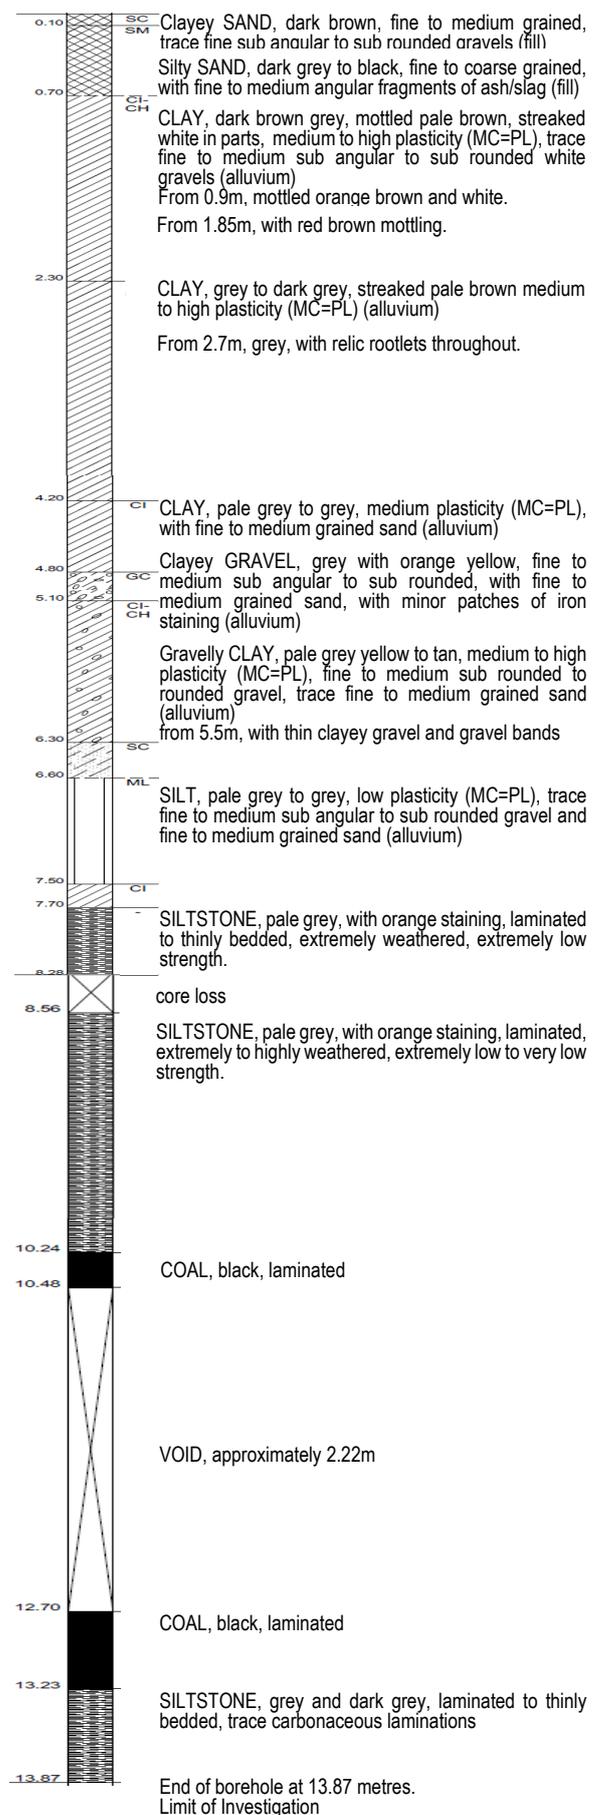
The immediate roof of the mine is made up of extremely weathered siltstone and claystone rock types of the Tighes Hill Formation (Hawley and Brunton, 1995), although at this site, only 3-4m of very low strength rock is present, and the upper 6-8m of the profile comprises stiff alluvial clays. The immediate floor of the Borehole Seam is the stronger Waratah Sandstone, however mines in the area typically left a small thickness (~300mm) of intact coal (referred to as “bottoms”) on the floor. The ground profile for the site, as recorded in a logged borehole, is shown in Figure 4.

Figure 4. Typical ground profile (BH1) from the site, which recorded standing workings (free-standing void) in the seam. (after GHD, 2017)

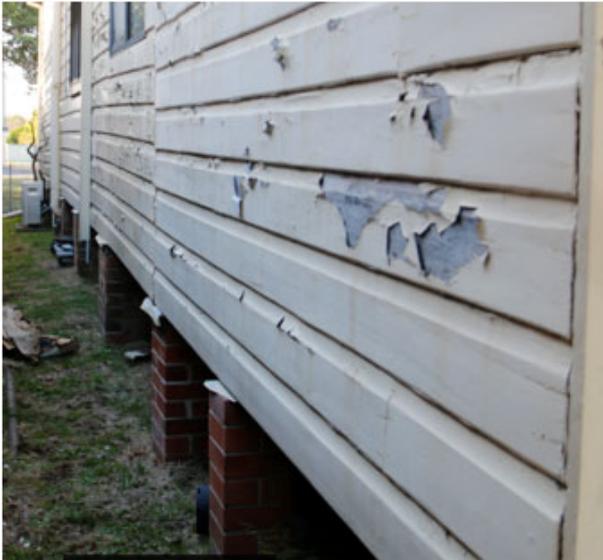
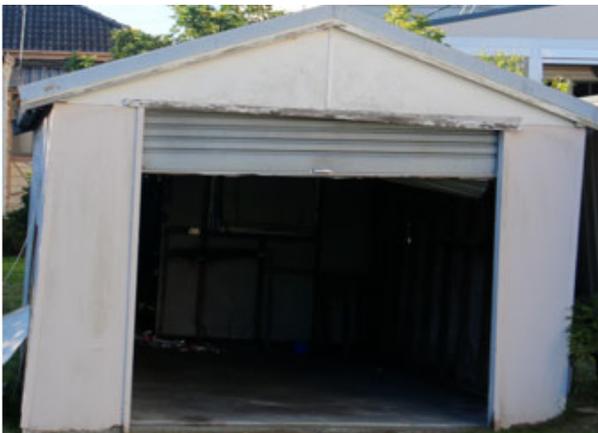
Sometime after mining occurred, a single-storey timber-framed weatherboard cottage was constructed on the site, founded on shallow isolated piers, spaced at between 1.5 and 2m. Accessible records of the site are available from 1961 onwards, and these document a number of subsidence events from 1963 to 1980 that severely impacted the property. Subsequent events from 1980, to 2018 resulted in further damage. Figure 5 (top) shows the curvature evident when sighting along the western wall of the house (the centre is higher than the ends by more than 200mm). Figure 5 (bottom) shows the tilt in the garage (which was tilted by 150mm from side to side).

Figure 5. Damage to structures on the site due to ground movements caused by subsidence.

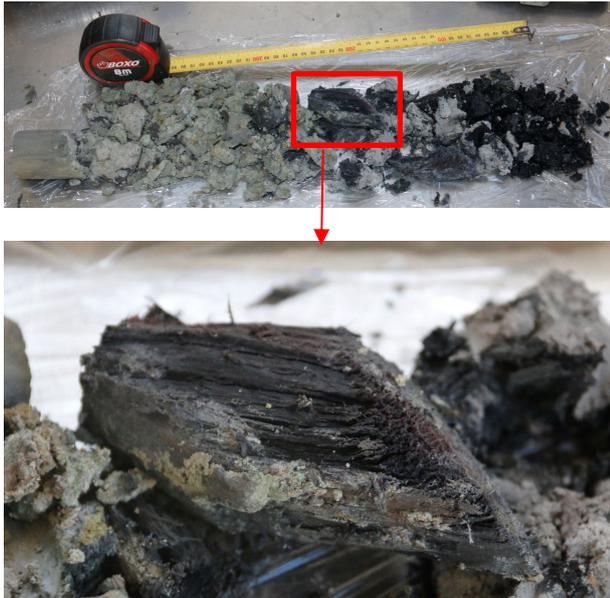
In addition to the 14 CPTu tests and the 3 cored boreholes, a sample was taken with a 0.5m long push sampling tube via the CPT rod string in CPT2a. motivated by the ambiguous results from CPT2. The sampling tube recovered what is interpreted to be a sample of extremely weathered siltstone roof material together with a section

of hardwood timber pit prop and weathered coal fragments shown in Figure 6. Due to the highly variable nature and poor spanning characteristics of the immediate overburden of the Borehole Coal Seam, mines in this area were known to heavily “timber” the roof, using hardwood props to provide standing support for the bords being mined. Commonly, this timbering was removed (if safe to do so) post mining, however in areas where secondary extraction (i.e. pillar removal) occurred, much of the timber used to support the roof had to be left in place.

Figure 6. CPT sample pushed at the level of the mine roof at CPT2a: 500mm of recovered material with EW siltstone to the left and coal fragments to the right (top); enlargement of hardwood timber fragment push-cored by the sampling tube (bottom).

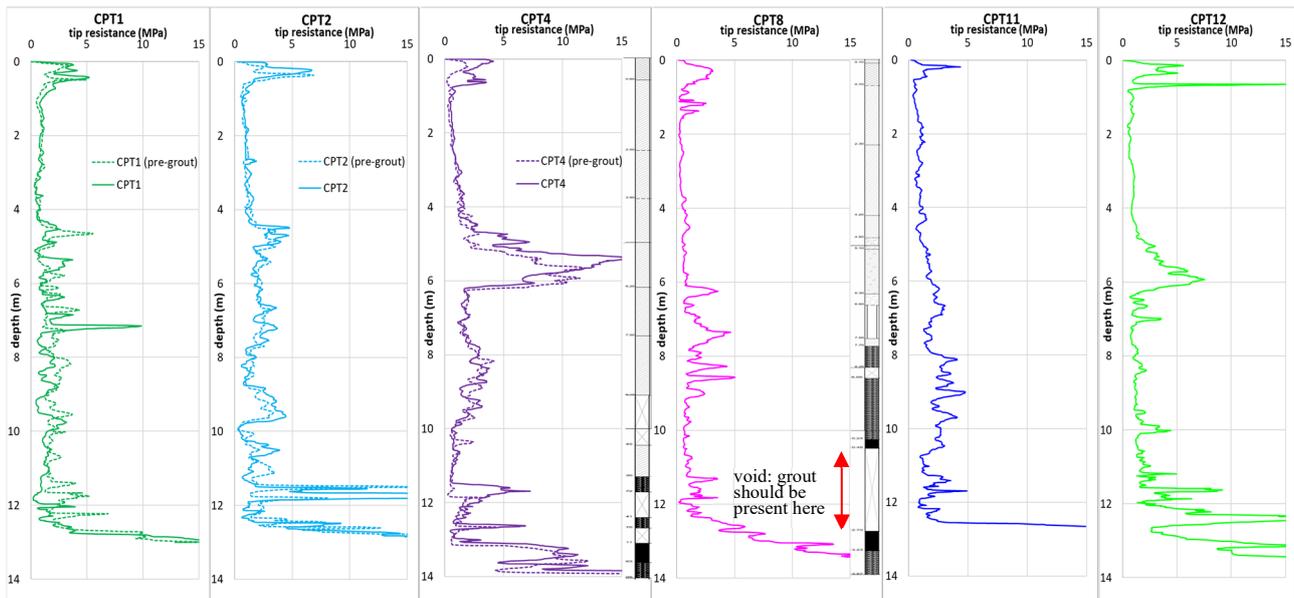
Figure 8. Individual tip resistance plots for selected CPT test locations.

A selection of tip resistance plots is presented in Figure 8. Tip resistance was only moderately useful to differentiated units in the subsurface profile. The fill layer at the surface was generally evident as a stiffer material with values between 4 and 7 MPa, reflecting some degree of surface compaction by site activity.

Below this, the alluvial clays generally displayed a consistent increase in stiffness with depth with few stiffer peaks. The gravel layer was only strongly evident in about half of the CPTs, and its tip resistance signature varied greatly both in terms of magnitude and position.

The interval between the gravel layer (~6.6m) and the top of seam (~10m) resembled the stiff clay above, except it was slightly stiffer, more erratic and did not exhibit the same consistent increase in strength with depth. For example, in CPT11, where the gravel layer was not present, the demarcation between the alluvial clay and underlying EW siltstone (~6m) is not at all distinct. Also as an example, in CPT8, despite a weakly developed gravel layer, the alluvial clay and underlying EW siltstone have essentially the same tip resistance signature.

The interval corresponding to the seam/workings is perhaps the most erratic, becoming more so approaching the base of seam/floor. This will be discussed further below.

Additionally, the CPT was found to be a poor instrument in determining grouting effectiveness at this site. The only profile highly likely to contain grout was CPT8 (shown in Figure 8), and the expected grouted interval was found to have a similar profile to the alluvial clay unit encountered nearer to the surface, over most of its thickness. The difficulty in confidently distinguishing grout on the post-grouting CPTu profiles was not helped by the low grout volumes that were recorded as being pumped underground at the site: in most locations, less than a cubic metre of grout could be injected, so widespread lenses/bodies of grout cannot be expected. This is a further indicator of likely significant convergence of the mine roof and mine floor over the majority of the site.

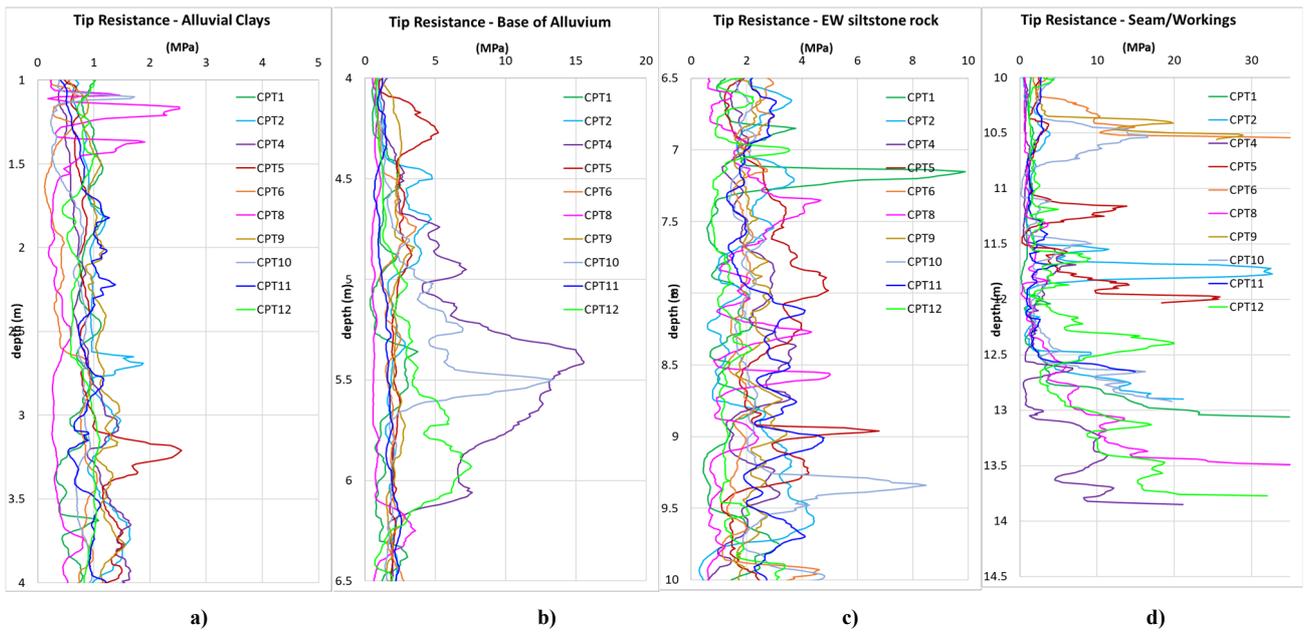
Figure 9. Tip resistance plots for identified subsurface units.

Figure 9 shows the specific intervals corresponding to the units identified in the borehole log of Figure 4. Figure 9a) compares the tip resistance profiles of the alluvial clays, which actually vary in average strength from around 300kPa (CPT8) to about 1MPa (CPTs 2 and 11), or, from soft to stiff. CPTs 2 and 5 seem to contain thin, stiffer lenses between 2.5 and 3.5m.

Figure 9b) compares the tip resistance profiles between 4m and 6.5m, which captures the gravel unit, where present. It is most well developed in CPT4 where it reaches a tip resistance of 15MPa, and less evident in CPTs 10 and 12.

Figure 9c) compares the interval from the base of the gravel to the top of the seam, and which contains the extremely weathered siltstone roof. The trends are variable, indicating that the roof material varies from a stiff to a hard clay. The only anomaly is the significant spike in CPT1 which possibly corresponds to an ironstone nodule, which are often found in the local siltstones of the area.

Figure 9d) is perhaps the most interesting interval as it corresponds to the interval that would contain the seam, or voids, or goaf (collapsed material). Overall, the interval is characterized by significant peaks at various levels throughout the extracted height of the mine, dropping back to values of greatly lower, and highly variable strength. Significantly, despite several profiles showing

very low strength soils in this unit, no intervals with zero tip resistance were encountered at any of the locations tested. Whilst this may be expected in profiles post grouting, if all voids were filled with grout, it also applies to the three pre-grouting CPT profiles in Figure 8 (CPTs 1, 2 and 4). The effectiveness of the CPT tests to identify the presence of grout is considered further later in the paper.

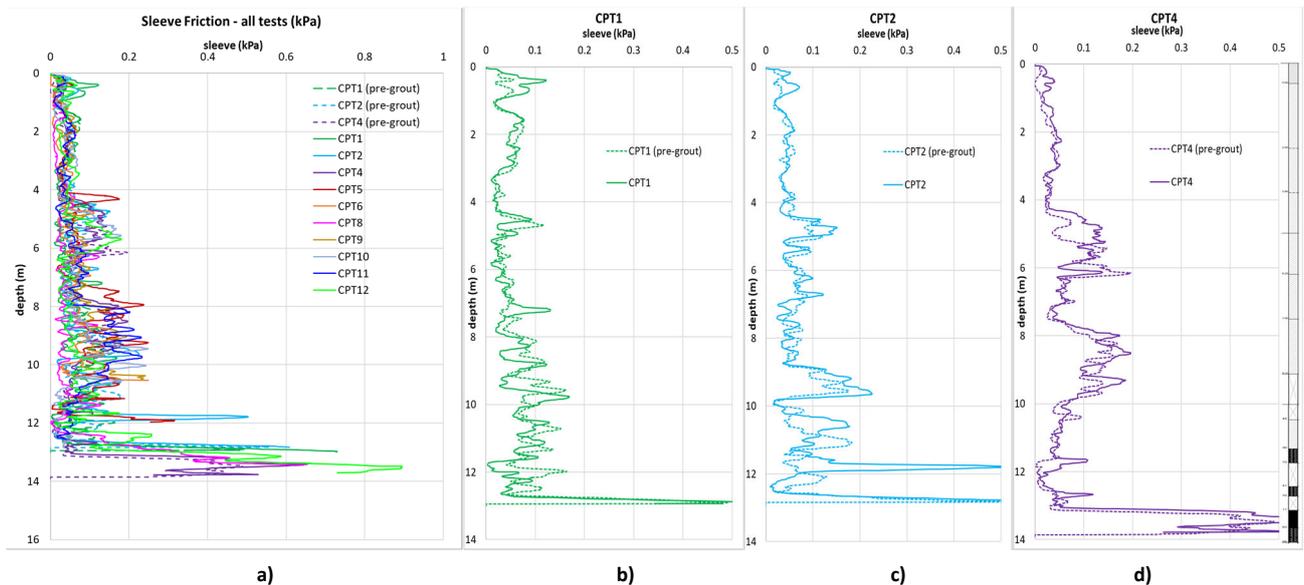
Figure 10. Sleeve friction plots for : a) all tests and, b) – d) paired pre and post grouting tests.

Sleeve resistance profiles are shown in Figure 10. Figure 10a) compares the sleeve resistance for all CPT tests. The sleeve signatures of each unit have similarly limited value as the tip resistance signatures previously discussed. Perhaps the only significant difference lies in the signature of the EW siltstone interval, which for the tip resistances more resembled that of the alluvial clay interval, but for the sleeve resistances more resembles that of the gravel.

Figures 10b)-10d) compare the CPTs for the site in its pre grouted and grouted condition. As for the tip resistance data, there were no discernable differences in the sleeve resistance due to grouting.

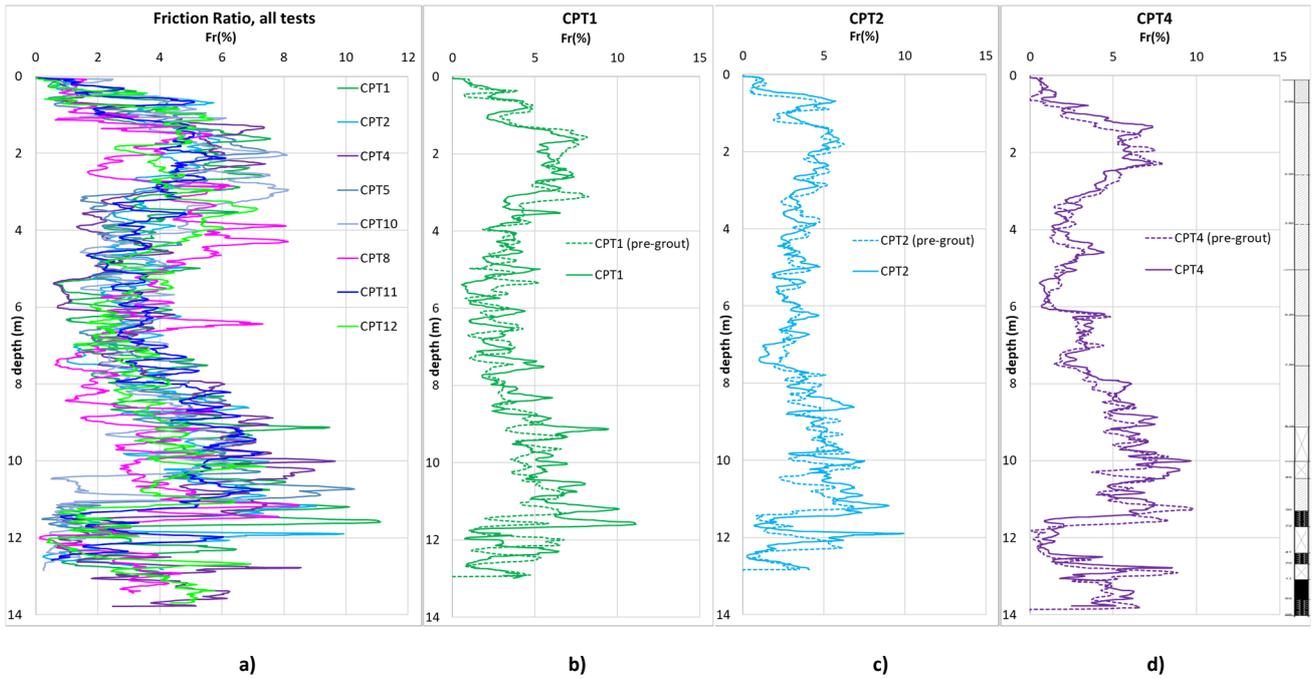
Figure 11. Friction ratio plots for : a) all tests and, b) – d) paired pre and post grouting tests.

Friction ratio profiles are shown in Figure 11. Figure 11a) compares the friction ratios for all CPT tests completed across the site. As can be seen from Figure 11a), the 4 identified units can be generally consistently inferred, however as with tip resistance and sleeve friction, there was significant variation in individual profiles.

Figures 10b)-10d) compare the CPTs for the site in its pre grouted and grouted conditions. As for the tip resistance and sleeve friction data, there were no discernible differences in the friction ratio due to grouting, with relatively even amounts of positive and negative variations throughout each profile.

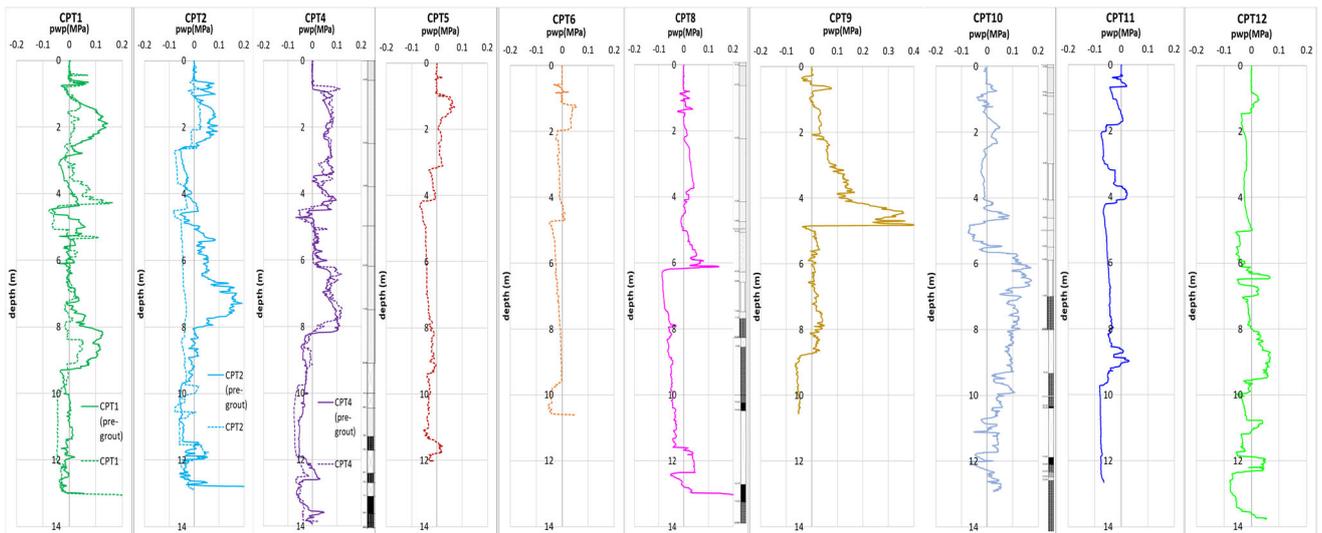
Figure 12. Pore water pressure results for paired CPTu tests, individual tests and CPTu/cored borehole paired tests.

The pore water pressure (PWP) results for each CPTu are displayed in Figure 12, together with paired tests or the profiles from closely located boreholes (if applicable). From Figure 12, it can be seen that the profiles of each CPTu test location vary significantly across the site, with inconsistent results, both pre and post grouting. Similar recurring features such as sudden drops in PWP and consistently negative pore water pressures are evident in all profiles, but at inconsistent locations. These anomalous drops in PWP and zones of negative PWP occur throughout the entire profile and are not limited to a single unit. CPT 11 recorded negative PWP values over almost its entire depth, whereas CPT 9 is predominantly

positive; CPT4 is predominantly positive in its upper part, and negative below, whereas CPT 9 is inclined to be negative in its upper parts and positive below.

There are no obvious reasons for the sudden changes and localized anomalies, but it is suspected that it may be indicative of a highly disturbed groundwater profile at the site. The boreholes on this site recorded standing water at relatively consistent depths of 7-7.5m, however on an adjacent site, water levels between 5.5 and 9m have been noted. Further evidence of a highly disturbed groundwater profile at the site exists from notes on the drilling logs of the grouting contractor noting that in around boreholes across the site anomalously wet clay was identified.

Overall, the PWP results, despite showing a highly anomalous groundwater table at the site, were not useful in understanding the physical characteristics or mechanisms of the subsidence that had occurred.
