Soil investigations and soil tests required for seismic inspection of abandoned tailings dams in Japan

S. Yasuda

ABSTRACT: Japan has mined many metals for centuries. Most of the mines has been closed due to the low total amount of ore deposits, leaving many abandoned tailings dams. Japan compiled its first design code for tailings dams in 1954. A tailings dam damaged due to the liquefaction of tailings materials in the 1978 Izuoshima-kinkai Earthquake. After the earthquake, many cyclic triaxial tests were conducted to study the liquefaction strength of the tailings. Based on the results, the code was revised in 1980. The existing tailings dams were examined and strengthened if needed, in accordance with the reviced code. Despite these inspections, three tailings dams failed during the 2011 Great East Japan Earthquake. The main reason for the failures was strong shaking. Based on detailed investigations, the seismic design code was revised again in 2012 to ensure the stability of tailings dams during strong earthquake motion. Failures of tailings dams during past earthquakes, the history of the revisions of seismic design code and examples of soil investigations, soil tests and an

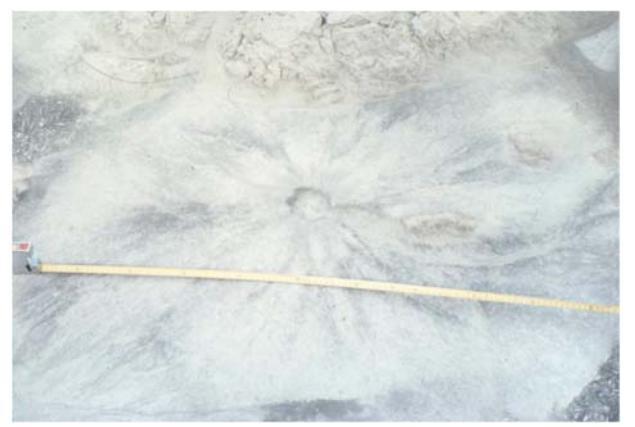
The 1978 Izuoshima-kinkai Earthquake, with a magnitude of Mj=7.0, caused serious damages to many natural slopes and a tailings dam at Mochikoshi Mine. The author and his colleagues visited the Mochikoshi Mine one week after the earthquake. Many sand volcanos were observed in the pond of the Houzukizawa tailings dam, as shown in Fig. 4. Fig. 5 shows the temporarily repaired Houzukizawa tailings dam. The tailings dam was constructed by the inner filling method, as shown in Fig. 6. It was considered that the dam failed due to the liquefaction of slime. About 80,000 m³ of slime and coarse tailings flowed out of the dam and down to a river and futher into a bay, as shown in Fig. 7. The river and the bay were contaminated by sodium cyanide, that killed many fishes.

Figure 4. Sand volcanos observed at the pond of the Houzukizawa tailings dam

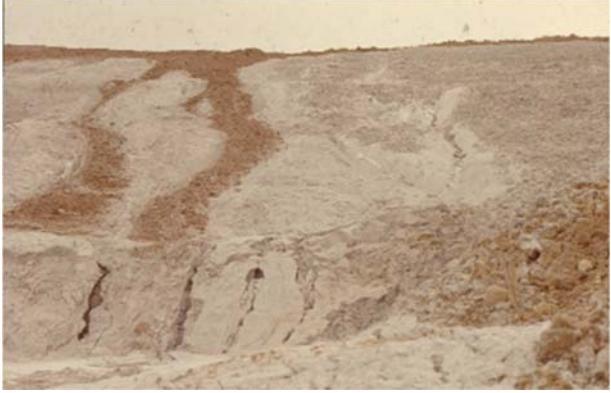
Figure 5. Temporarily repaired Houzukizawa tailings dam at the Mochikoshi Mine

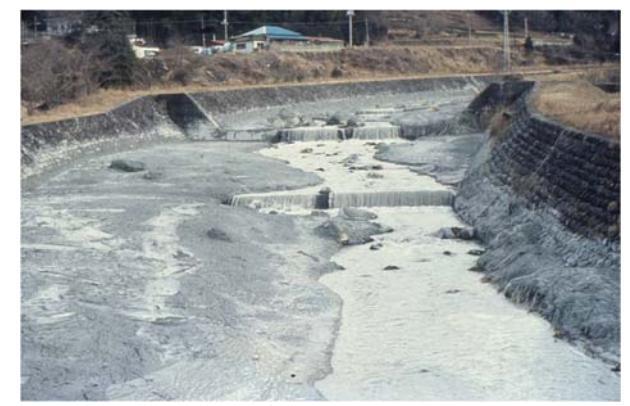
Figure 7. Flowing slime in the Kano River

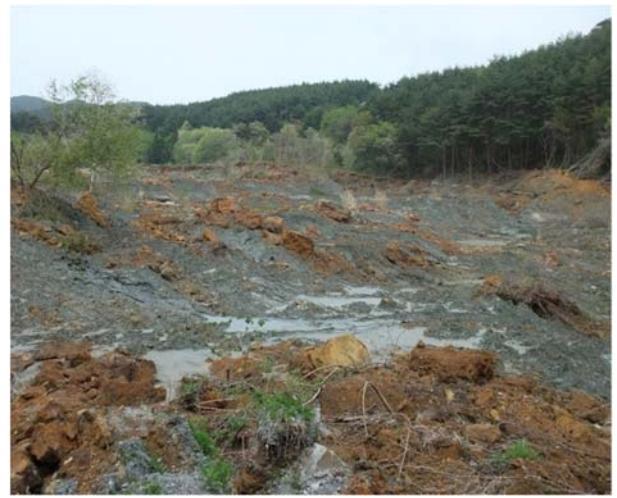
Figs. 10 and 11 show the failed slope and its cross section, respectively. The dam was constructed by the inner filling method by discharging slime. Sand volcanoes were observed on the ground surface of the pond. Based on detailed soil tests and analyses, it was concluded that slime above the foundation bank slid due to liquefaction (Ishihara et al. [4]), as shown in Fig. 11, and flowed 1 km downstream into houses and fields. The river downstream was contaminated with arsenic. In the restoration work, the slime behind the starter dam was treated by mixing it with cement to prevent liquefaction and the starter dam was covered by stone mass make it higher and stronger as shown in Fig.12, based on the analysis results of stability of dam slope under Level 2 earthquake motion as specified mentined later.

Figure 10. Failed upper slope of the Kayakari tailings dam

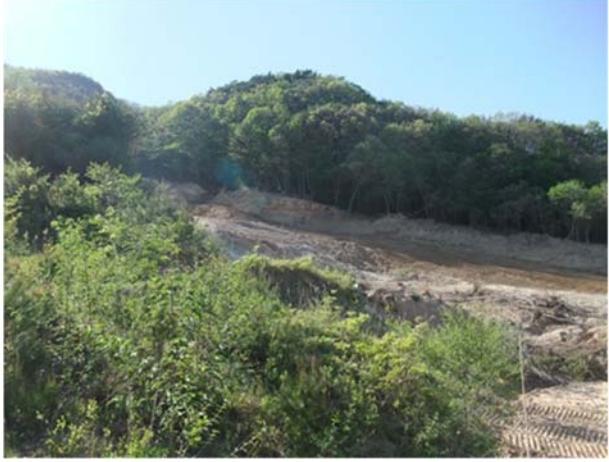
Figs. 13 and 14 show the failed slope and its cross section of the Zenigami tailings dam at the Takatama Mine, respectively. The dam was constructed by the inner filling method by pasting slime. No sand volcano was observed on the failed slope. Based on detailed soil tests and analyses, it was concluded that the tailings in the upper slope of the dam failed, as shown in Fig. 13, and flowed over a road and into a river. The road was temporarily closed. In the restoration work, a new starter dam was constructed slightly higher than the existing starter dam. The failed tailings were then filled behind the new starter dam at a gentle slope to prevent sliding failure in the future earthquakes. A counterweight fill was heaped on the downstream slope of the existing starter dam to prevent sliding during earthquakes.

Figure 13. Failed upper slope of the Zenigami tailings dam

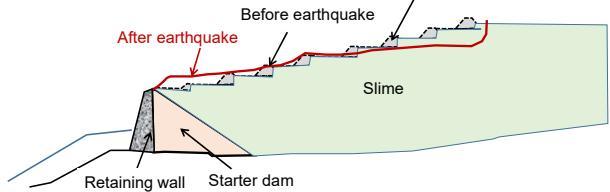
Figure 15. Cross section of the Gengorou tailings dam

Fig. 15 shows a cross section of the Gengorou tailings dam at the Ashio Mine. The dam was constructed by the inner filling method by discharging slime. Slime above the foundation bank slid and flowed over a railway and into a river. The railway was temporarily closed. The river was contaminated by lead.

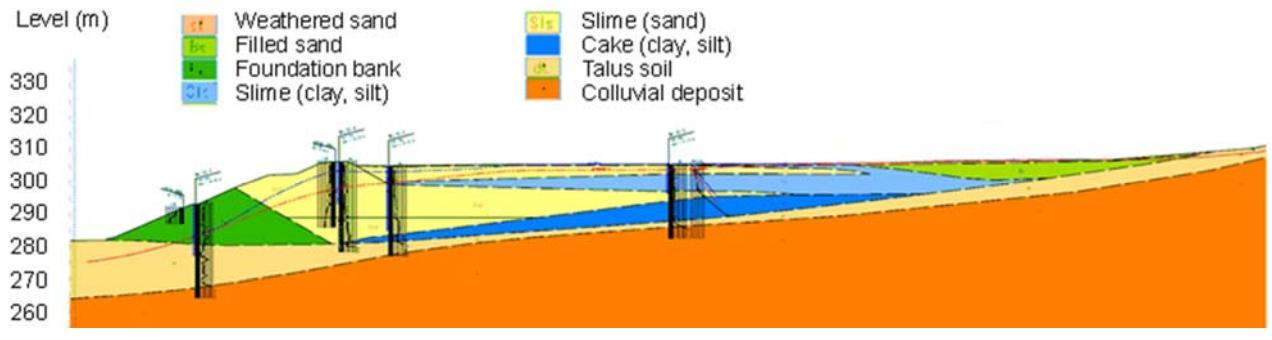
The location of the inspected tailings dam is shown in Fig. 9. The dam was not damaged during the 2011 Great East Japan Earthquake, although it was subjected to a slightly higher seismic intensity of 5 in JMA scale. Detailed soil investigations, including borings, standard penetration tests, PS loggings, measurement of the ground water table, undisturbed samplings, triaxial tests, and cyclic triaxial tests, were conducted. The estimated soil cross section of the dam and the tailings is shown in Fig. 17. The stability of the slope of the dam under Level 1 earthquake motion was analyzed first based on the seismic design code of 1980. The results showed that the safety factor against liquefaction, F_{L_1} was greater than 1.0 and the safety factor against sliding, $F_{\rm s}$, was 1.2 under a seismic coefficient of $K_h = 0.15$. Therefore, it was confirmed that this tailings dam was stable according to the current design code. Then, the stability of the slope of the dam under Level 2 earthquake motion was analyzed in the following four steps:

Figure 17. Estimated soil cross section at a recently inspected tailings dam

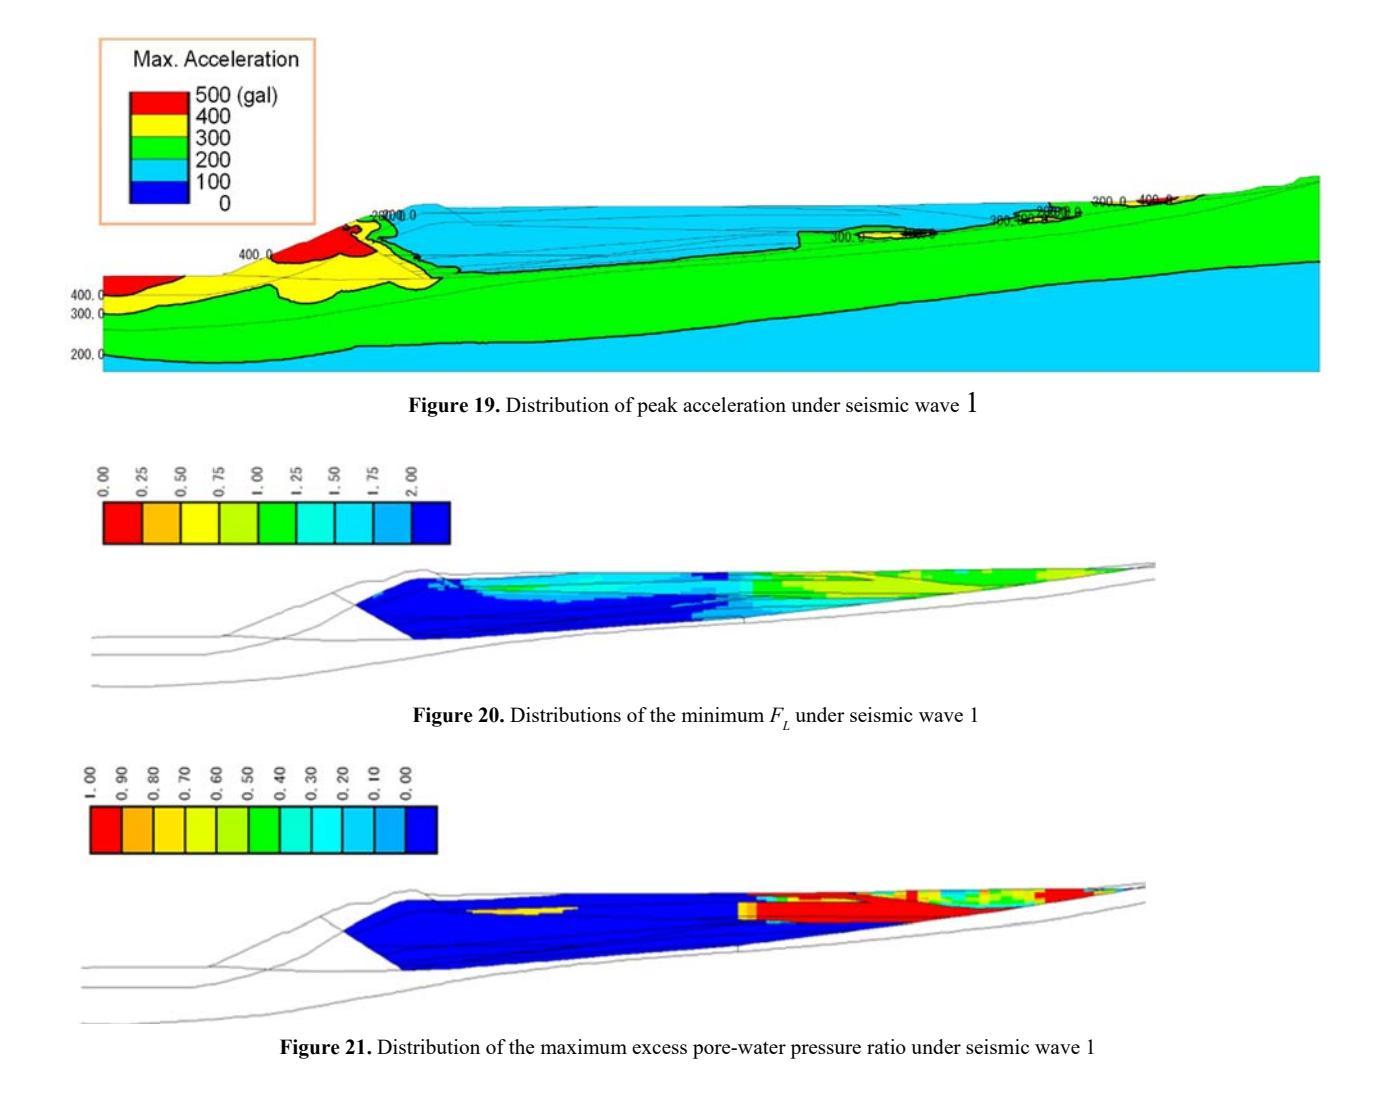
Figure 19 shows the distribution of peak acceleration under seismic wave 1. The peak acceleration increased gradually from the bottom of the slope to about 500 gals (cm/s^2) at the surface of the slope. Figs. 20 and 21 show the distributions of F_L and the excess pore-water pressure ratio, respectively, under seismic wave 1. The shallow parts of tailings slime in upper zone liquefy and the excess pore-water pressure ratio U_L/σ_v reaches 1.0. The liquefied zone is almost the same under the seismic waves 2 and 3. Fig. 22 shows assumed several slip surfaces and sliding displacements along these surfaces under seismic wave 1. The maximum sliding displacement which occurs in upper zone is 16 cm. Fig. 23 shows the time history of the input seismic wave 1, the excess pore-water pressure, the safety factor against sliding, F_S , and the sliding displacement along this sliding surface. The estimated sliding displacement is not large enough to cause flow of the liquefied slime. Therefore it was judged that the tailings dam is stable under Level 2 earthquake motion.

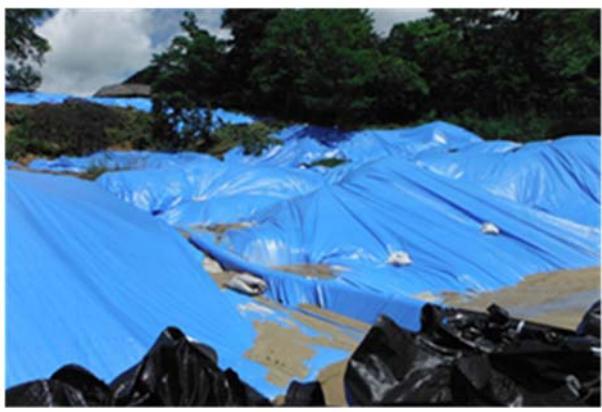
A strong foreshock of the 2016 Kumamoto Earthquake hit Kumamoto in Japan on April 14. The main shock, with a magnitude of Mj=7.3, hit 28 hours later. Many houses and buildings collapsed due to the strong shaking. An abandoned tailings dam at the Taio Mine failed during the main shock, as shown in Fig. 24. Soil investigation, laboratory tests and a stability analysis were conducted to restore the failed slope with appropriate countermeasure. Fig. 25 shows a soil cross section established by the investigation. Slime was very loose, with an SPT N-value of 0 to 1, and the liquefaction strength ratio, R_L (CSR), obtained by a cyclic triaxial test, was very small, about 0.2. Based on slope stability analysis, it was concluded that the sliding failure occurred due to an increase in pore water pressure in the slime. The lattice type cement mixing method with grids of 4.4 m square and 10 m deep was applied in the restoration to prevent sliding during future earthquakes, as shown in Figs. 25 and 26.

Figure 24. Failed slope of a tailings dam at the Taio Mine

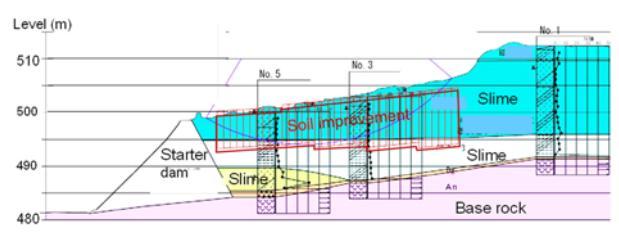
Figure 25. Cross section of the tailings dam
