# You can leave your head on ... Geophysics serves non-destructive in-situ inspections of ground anchors

**ABSTRACT:** Higher awareness for awards of damages caused by public infrastructure forces public administration in the Republic of Austria for tighter monitoring intervals of existing ground anchors. In an Alpine country with denumerable infinite ground anchors, road office tradition and national standards request statistical selection of anchorages, restressing routines and documentation of tendon displacements. Conclusion when failed: Surgery successful, patient / anchor be-headed, slope destabilized by next thawing season, good business idea for construction companies as endless financial resources are available through the taxpayer. A contracted research project aimed to the development of a non-destructive in-situ measurement strategy for timeworn ground anchors. By combining geophysical field methods (in-situ resistivity / induced polarization, self-potential, acoustic frequency shifts) four risk classes were detected among single members of anchor ensembles. The applied strategy re-set the focus from individual anchor testing to the overall geogenic functionality while

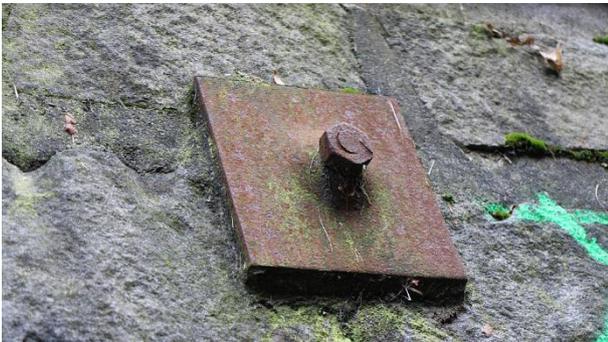
Figure 4. Short-headed tendon face on legacy anchor

Further, the on-site situation may not always be favorable to connect pulling devices to the tendon: Either the free end of the legacy tendon is too short to force fit a jacking mechanism, Fig. 4, or on-site realities prohibit long and expensive preparations (scaffolds, service benches, road blocking over two hours), cf. Fig. 5.

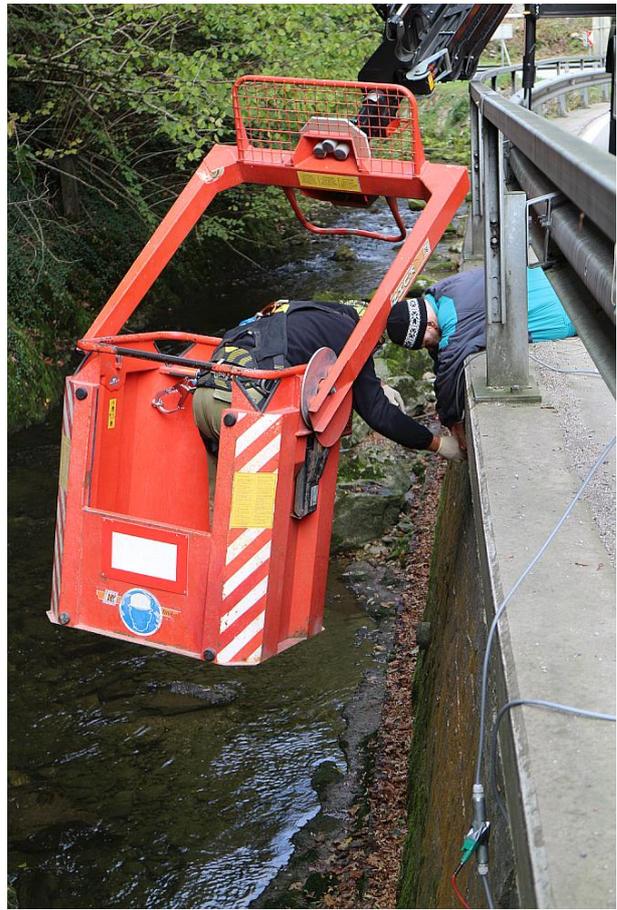
Figure 5. Example of operational reality

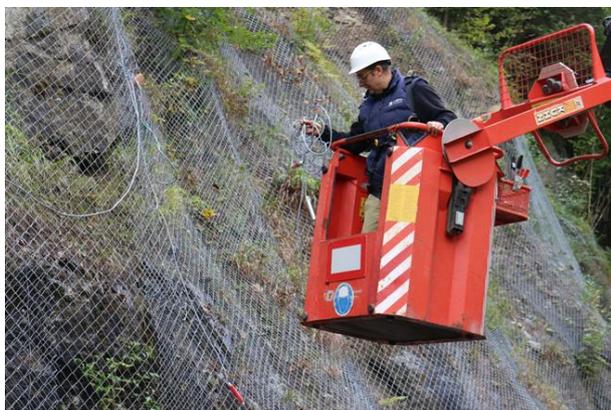
Figure 7. On-site installation of electrodes for the subsequent geoelectric survey

In a third step, the **geoelectrical survey** is prepared by visiting all anchor with a portable hoisting platform, Fig. 7. This allows the removal of the rust film (battery driven grinder) and the good connection of the contact vices, Fig. 8. Depending on the electrode configuration preferred, one current electrode will be placed into infinity – meaning: a distance more than ten times the maximum distance between two anchors in the anchorage cluster.

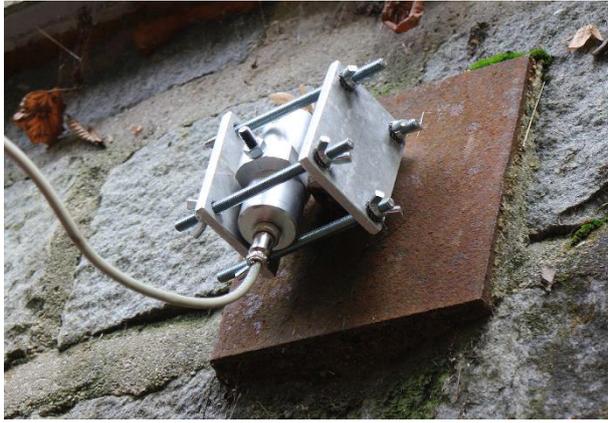
**Figure 9.** Force-fitted installation of the accelerometer sensor to conduct acoustic logging measurements.

If decided (*and financed*), the team will return to the respective site to conduct planned acoustic logging / seismic measurements. The accelerometer sensor will be force-fitted to the anchor head, Fig. 9. A sharpened chisel (point source!) is placed on the anchor plate and very careful tapped with a small upholsterer hammer (hammerhead 200 g), Fig. 10.

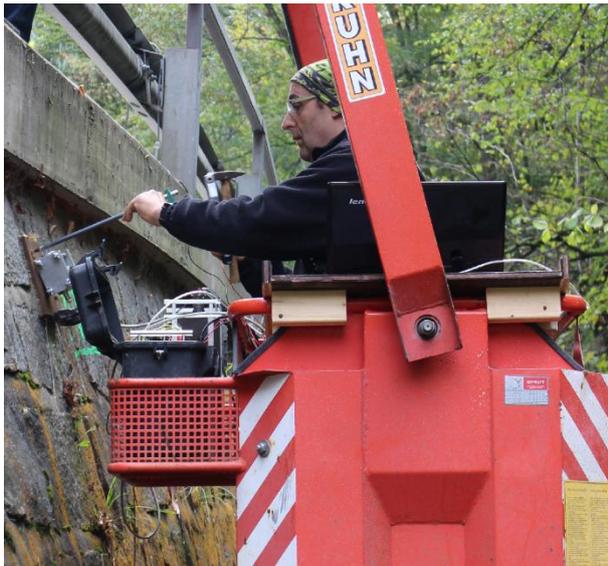
**Figure 10.** Conduct of acoustic logging measurements.
