Delineation of uncontrolled seepage pathway within an earth dam using geo-electrical methods

ABSTRACT: Earth Dams are designed to permit the flow of seepage water from the reservoir through its foundations or embankments. However, the flow of seepage water through other preferential flow paths other than the designed filter zones and relief wells can be detrimental to the overall stability of the dam. The electrical resistivity and induced polarization methods were used to delineate possible seepage zones and uncontrolled seepage pathways within an earth dam for hydroelectric power generation. The electrical resistivity tomography obtained for various traverses along the earth dam were able to detect possible seepage zones. The potential seepage pathway within the dam was further delineated using the electrical resistivity results. Borehole drilling will however need to be used to confirm the delineated seepage pathways and remedial measures put in place to forestall any failure of the dam.

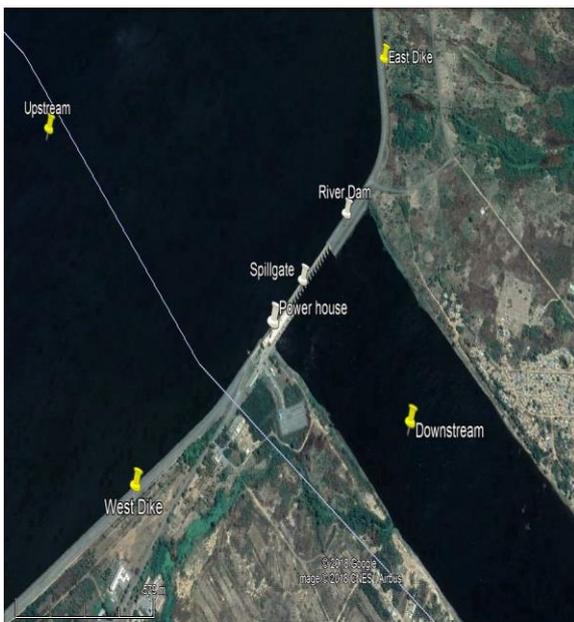
The Kpong dam was constructed over the Volta River in Ghana in 1982 for hydroelectric power generation. The main river dam is 239.74m in length and is joined to the west by the West Bulkhead, the Powerhouse, the Centre Bulkhead, the Spillway, and the West Dike. Also, to the East of the river dam is the East Dike. Fig. 1 shows a plan view of the Kpong Dam. The maximum designed elevation of the crest of the river dam and the two dikes is 18.25m National Datum level (NDL). The dikes are provided with both total and partial core trench cut-offs on the east and west banks. The functions of the cut-off trenches are to reduce the loss of reservoir water through the foundation or to prevent the subsurface erosion by piping through the foundation. Some differences exist between the excavation for both total and partial cut-off trenches. While the total core cut-off trench is excavated to the bedrock, the partial core cut-off trench is excavated to only 3m deep into the overburden foundation. The excavation also depends on the competency of the overburden foundation. A weaker overburden, therefore, results in a total cut-off trench and vice versa.

Figure 1: The Kpong hydroelectric dam (Source: Google earth)

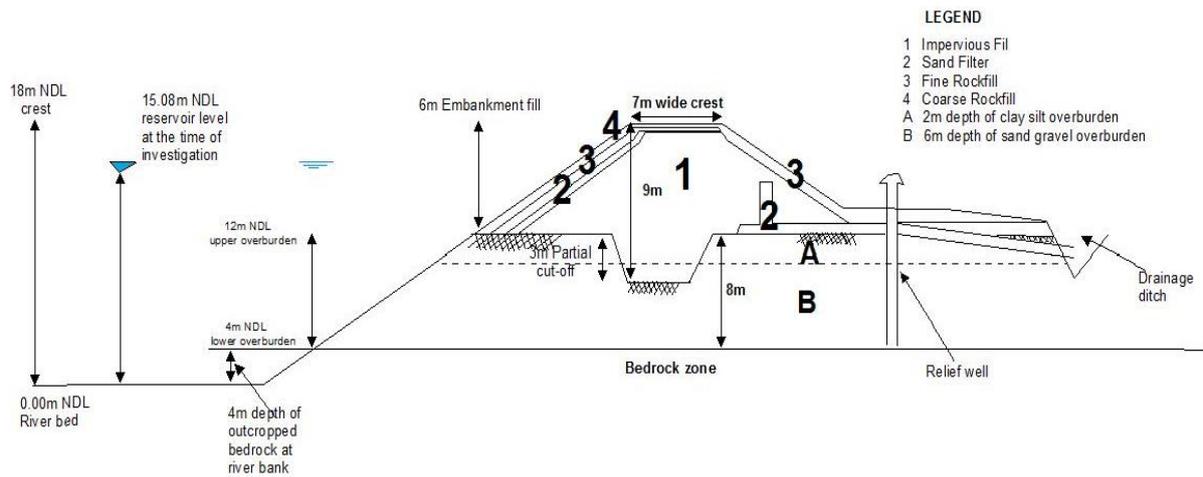
The east dike is a typically zoned embankment made up of mainly three sections namely; the core, the filter and fill materials. The core which is composed of impervious fill consists essentially of silty clay, the clay fraction varying between 25% and 65%. Also, the designed plasticity index of the impervious core is between 10% and 40%. The filter material is placed above the impervious layer. The filter layer is made up of sand mixed with about 10% crushed fines. The major function of the filter is to prevent the washout of materials from the impervious layer. Again, it serves as a drain for seepage water from the reservoir.

At both the upstream and downstream of the dike is the fine rockfill of varying sizes from 150mm to 0.074mm crush rock. Lastly, coarse rock fill, up to 750mm, is laid at the upstream side of the dike. Both the fine and coarse rock fill collectively is termed the Fill. Its purpose is to receive the load from the water and transfer it safely to the ground. Also, relief wells sunk to the bedrock have also been installed along the first berm of the East Dike at varying intervals and at locations depending on the permeability and thickness of strata of the bedrock. These wells were designed with plain and screened PVC pipes. The section of the east dike studied lies between Km 4+705 to 4+945 and falls within the partial cutoff trench of the East Dike. A typical section of the partial cutoff trench is shown in Fig. 2. Also for the section under study, the overburden material has an average elevation of 12m NDAL with reference from the river bed at elevation 0.00m NDAL. However, the overburden comes into contact with the bedrock outcropping at elevation 4m NDAL at the riverbank of the east dike at the study section. This gives the thickness of the overburden to be approximately 8m. Therefore, 6m thick layer of the overburden is made up of sand and gravel and is overlain by silt and clay of varying proportion of 2m depth. Also, the maximum elevation measured on the crest of the dike is 18m NDAL. The overall structural height of the Dike can, therefore, be estimated to be 6m thick from the overburden.

Figure 2: Detail cross-section of the dike at study section

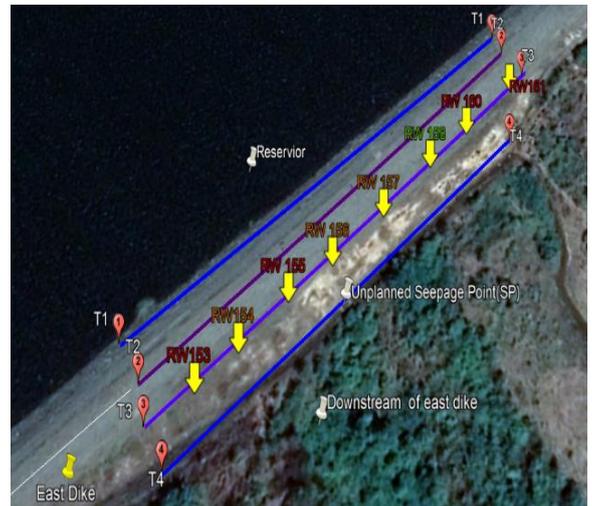
The data for both resistivity and induced polarization were acquired simultaneously along four (4) traverse lines (T1, T2, T3 and T4) using the ABEM Terrameter LS. The four traverse lines were established at intervals along the embankment starting from the top of the crest to the toe drain. Traverse line 1 was established on top of the 7m wide embankment crest. The average elevation of the crest measured is 18m National Datum Level (NDL). Traverse line 2 was established along the slope of the dike and at an elevation of 16m NDL. It also measures 13m from traverse line 1. Traverse line 3 was stationed along the first berm of the east dike and directly in front of eight relief wells. It was at a distance of 18m away from traverse line 2 and at an average elevation of 12m NDL. Traverse line 4 was established at 18m away from traverse line 3 and close to the unplanned seepage exit point. This seepage exit point is about 98m from the start of traverse line 4. Fig. 3 shows the four traverse lines in plan view. The gradient plus array was adopted for the electrical resistivity measurements with a 2m electrode spacing and a 4x21 cable layout. The total length of each traverse line was 240m. The “roll along” technique was therefore adopted for the survey to ensure the total length of 240m is covered. The targeted depth of investigation considered was 25m.

Figure 3: Four traverse lines for resistivity measurements

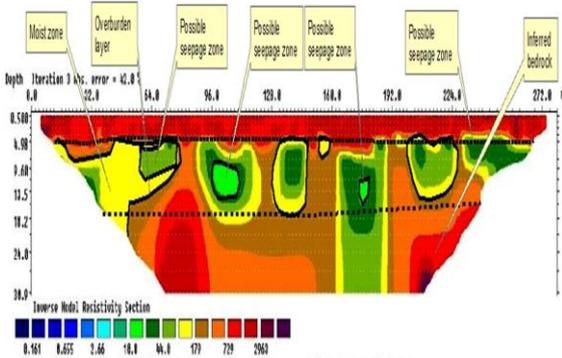
The inverted resistivity cross-section obtained for traverse line 1 is given in Fig. 4. It shows a high resistive layer between $700\Omega\text{m}$ and $2000\Omega\text{m}$ within the first 5m depth of investigation. This layer might be made up of the coarse and fine rockfill. Between the 5m and 14m depth of investigation are layers of varying resistivity ranging from as low as $10\Omega\text{m}$ to $800\Omega\text{m}$. This depth is inferred to span from 5m below the crest of the dike to the overburden-bedrock interface. Materials within this depth are therefore predicted to be composed of a portion of the silty clay core, an upper silt and clay overburden material underlain by sand and gravel overburden material. However, at distances 42m to 78m, 96m to 112m, 122m to 138m, 170m to 180m and 232m to 270m within the overburden between the depth of 9m and 11m, very low resistivity ranging from $10\Omega\text{m}$ to $50\Omega\text{m}$ are observed. These zones fall within the lower layer of the sand gravel overburden material, and might, therefore, be possible seepage zones. Again, from distance 164m to 192m is a zone with relatively higher resistivity from $100\Omega\text{m}$ to $170\Omega\text{m}$ spanning downwards from the overburden to the bedrock. Underlying the 14m depth of investigation is another layer of a higher resistivity ranging from $180\Omega\text{m}$ to about $3500\Omega\text{m}$. This may be the bedrock with the lower resistivities recorded inferred to be the interface of the overburden and the bedrock.

Figure 5: Resistivity pseudosection of traverse line 1

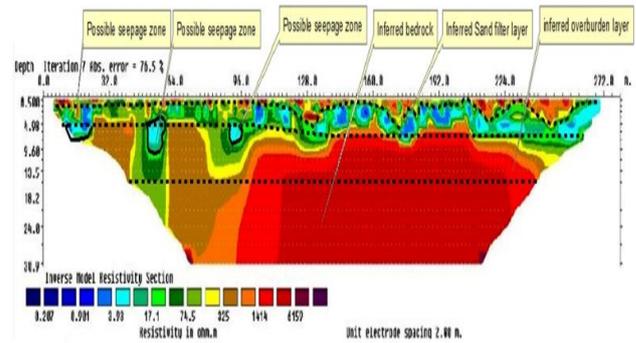
The resistivity image of traverse line 2, showed a top layer of relatively high resistivity of between $65\Omega\text{m}$ to $700\Omega\text{m}$ along the whole stretch of the investigation (Fig. 5). This layer which is about 1m deep is inferred to be the fine rock fill layer of the dike. Underlying the 1m depth fine rock fill layer to a depth of about 4m is a very low resistivity material ($<4\Omega\text{m}$). This the depth hosting the vertical sand filter of the dike. This very low resistivity ($<4\Omega\text{m}$) recorded may therefore be as a result of the sand filter layer being saturated with seepage water. Also, extending from the 4m depth to about 9m depth are pockets of low resistivity zones also with low resistivity $<4\Omega\text{m}$ occurring within the silt clay and sand gravel overburden material. These zones might be potential seepage zones and include distances 10m to 26m, 50m to

62m, and 90m to 96m. Beyond 12m depth is a very high resistivity ($>1500\Omega\text{m}$) zone which may represent the underlying competent bedrock.

Figure 4: Resistivity pseudosection of traverse line 2

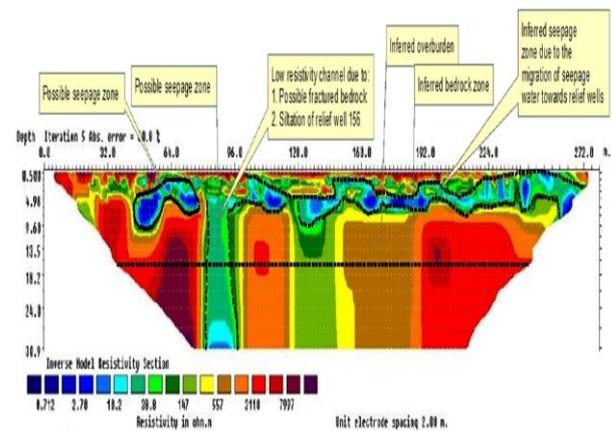
The resistivity image obtained for traverse line 3 showed a thin layer of about 1-meter depth having a resistivity up to about $500\Omega\text{m}$ (Fig. 6). This depth is predicted to be the fine rockfill around the relief wells. Beneath this 1m thin layer to a depth of about 6m, is a low resistivity material ($<25\Omega\text{m}$) from 102m to 270m distance. This layer is inferred to occur within the silt-clay underlain by sand gravel overburden layer. It is anticipated that the flow of seepage water migrating from the reservoir through the overburden would find its way into the relief wells, where it would be subsequently drained out. Therefore, the low resistivity ($<25\Omega\text{m}$) at this depth could be as a result of the concentration of seepage water within the sand gravel overburden from the reservoir. Again, a low resistivity zone of $<25\Omega\text{m}$ is recorded from distance 78m to 96m and at a depth ranging from 4.5m to 28m. This low resistivity recorded could be a zone of saturation. The possible seepage zones within this traverse line include distances 44m to 78m and 82m to 96m which recorded low resistivity of $<25\Omega\text{m}$ within the overburden layer. Below the 6m level is a material with resistivity $>500\Omega\text{m}$. This layer is inferred to be a competent layer such as the bedrock.

Figure 6. Resistivity pseudosection of traverse line 3

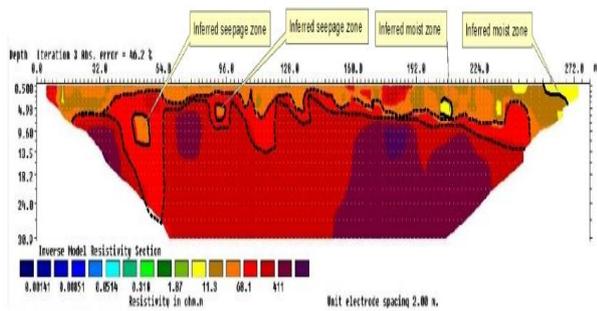
The pseudo section of traverse line 4 exhibits resistivity between $10\Omega\text{m}$ to $50\Omega\text{m}$ within an average 3m depth of investigation as shown in Fig. 7. Beneath the 3m depth to about 8m depth is another zone with a resistivity of about $70\Omega\text{m}$ - $150\Omega\text{m}$. These two depth ranges which could be moisture-filled, are inferred to occur within the overburden materials, namely; silt and clay underlain by sand and gravel material respectively. Below the 8m depth are zones of high resistivity $>400\Omega\text{m}$, which could be a competent layer. Potential seepage zones can be inferred to be between distances 50m to 58m and 90m to 98m and at a depth between 5m and 9m, which had very low resistivities of about $2\Omega\text{m}$.

Figure 7. Resistivity pseudosection of traverse line 4

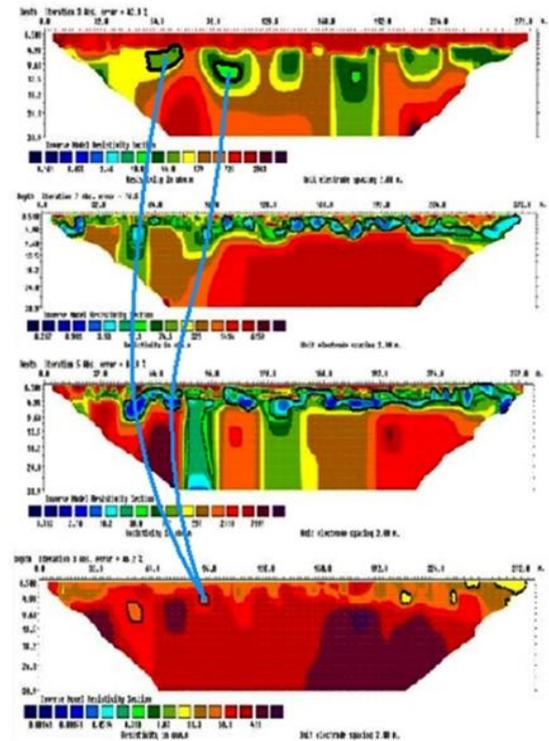
Based on the results of the resistivity sections, the potential unplanned seepage pathway is inferred to occur within the lower sand and gravel layer of the overburden material (Fig. 8). The potential unplanned seepage pathway is therefore delineated as follows: Between distances 42m to 78m and 96m to 112m at an average depth of 11m for traverse line 1, 50m to 62m and 90m to 96m at 9m average depth for traverse 2, 44m to 78m at an average depth of 5m for traverse 3, and between distances 90m to 98m at a depth of 5m for traverse line 4. In terms of elevation, the seepage pathway is at an average elevation of 7m NDL.

Figure 8. Possible delineated uncontrolled seepage pathway from resistivity results

Further study is required to unravel the unplanned seepage conditions at the downstream end of the east dike using a combination of geophysical methods including self-potential. Drilling can also be carried out at the downstream end to confirm the delineated seepage pathway.
