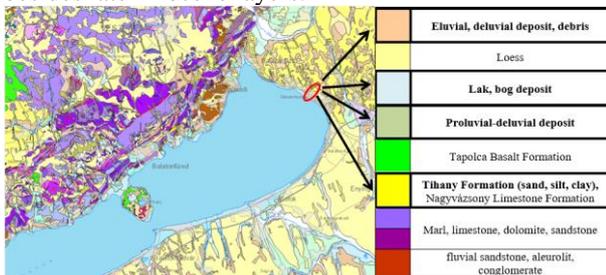
Figure 2. Geological map of the examined area [18]

The detail of the geological map of Hungary [18] of the eastern part of the lake displays loose and partly cemented sediments (Fig. 2). It is clear how different layers make up different parts of the coastline. The layers of the studied area are highlighted.

The excavations revealed 1-2 m thick Holocene layers underlain by the deposits of 'Tihany Formation', which consists of different grain size but predominantly fine sand and silt. These are sediments of the preexisting deltas arriving at Lake Pannon [19]. The cold winds of the ice age formed a thin loess cover, which has been already eroded in many places, and elsewhere it is only present in a maximum thickness of a few meters. Loess is missing from the study area. On the lakeshore, lacustrine and bog deposits are found, while on the rest of the coast, eluvial deposits and debris are common besides late Miocene layers.

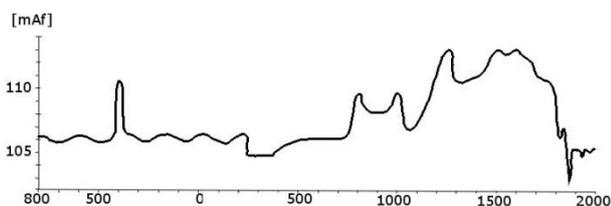
Figure 3. Changes in water level of Balaton from the 9th to the 20th century [20]

Balaton has eroded the slope in the past period due to wave action, and sediments were deposited at the lakeside zones. Fig. 3 shows the changes in the water level of Lake Balaton from the 9th to the 20th century.

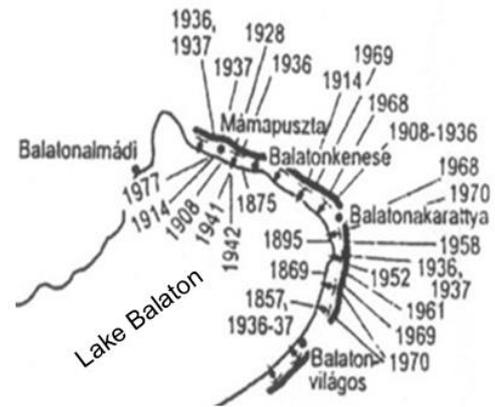
Figure 4. Landslides in the surroundings of the study area [9]

The geomorphological setting and geological successions result from a very intense evolution period, especially during the Holocene. Slope movements have long been observed and described. Before the 19th century, there were two major islands before Balatonakarattya, which slope surfaces may have formed extended deep below the lake bed, thus causing bed rise. Significant surface movements also occurred in the early 20th century [9] (Fig 4).

At that time (1914), a railroad train also fell victim to the movements. Morphological and geological investigations were carried out [21], then a general geomorphological model was made for the movements of slopes near Balaton [9] (Fig 5).

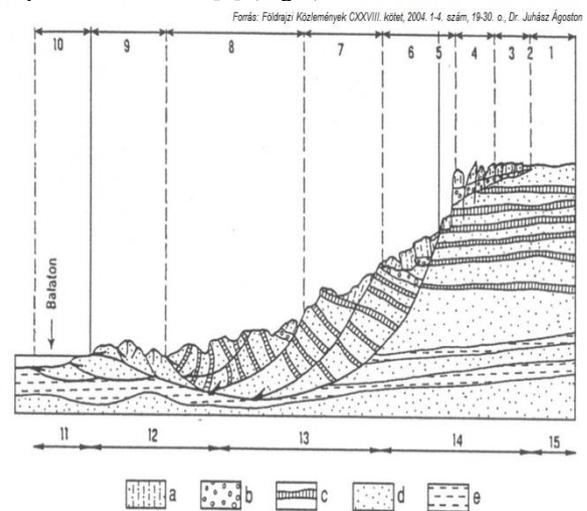
Figure 5. general geomorphological model of the movements of slopes near Balaton [9]

Key:  
 1 - areas of landslide hazard; 2 - boundary line of fissures;  
 3 - cleavage zone; 4 - humps with collapse hazard; 5 - failure front of the slide; 6 - accumulation zone of the deformed matter; 7 - zone with landslide hazard; 8 - zone of slopes with temporary rest; 9 - compression zone of landslides; 10 - stabilized remains of former slumps.  
 Dynamic state: 11 - stable zone at the base; 12 - zone of pressure tension; 13 - transitional zone of dynamically changing tensions; 14 - zone of shear and pull tensions; 15 - stable surfaces;  
 a - loess, sandy loess; b - gravel; c - Pannonian series with variegated clay; d - Pannonian sand; e - Pannonian clay

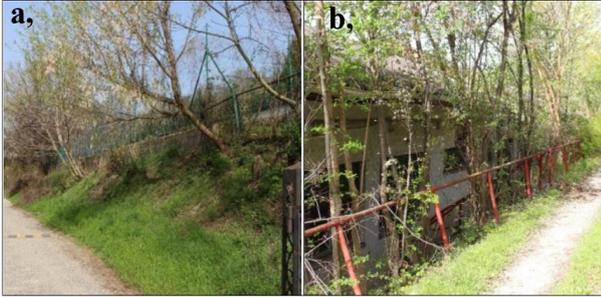
Figure 6. Field observations

Several signs of slope movements are visible in the area. Two examples are displayed in Fig. 6, which shows curved trees and fallen, curved barriers suggesting a slow creeping movement of the shore.

The retaining wall at the bottom of the slope is cracked, and little debris is in motion. Little springs appear on the slope, which represents the outflows of subsurface waters. Finally, at the edge of the top of the slope, local slumps can be seen. These signs all indicate a complex process of motion.

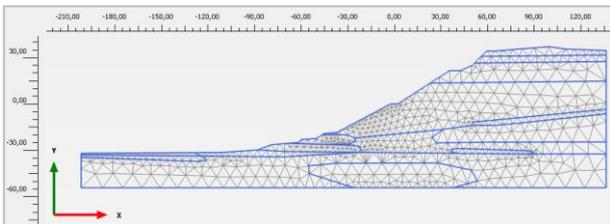
Figure 7. Finite element mesh

Fig. 7 shows the finite element mesh generated in Plaxis.

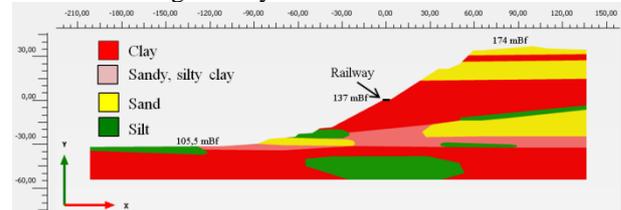
Figure 8. Examined section, modell geometry

A geodetic survey of the terrain was available. To define soil stratification, an 80 meters deep drilling and a 60 meters deep geophysical survey measurement from the top of the slope, 30, 20 and 15 meters deep explorations and one CPT probe at the bottom of the slope macroscopic layer descriptions was used. Fig. 8 shows the layers of the drawn section, which was also used as model geometry.

Excavations were made on top and bottom of the high shore, so the geometry of the layers between them was created based on knowledge of geological development.

The foot of slope begins with lake sediments, then the debris slope is built with the mixed layers of early movements. In the predominantly clayey environment of the slope, the lake's varying water levels for centuries may have formed lenses of silt and sand. The water level was modeled between 103.5 and 105 mBf.

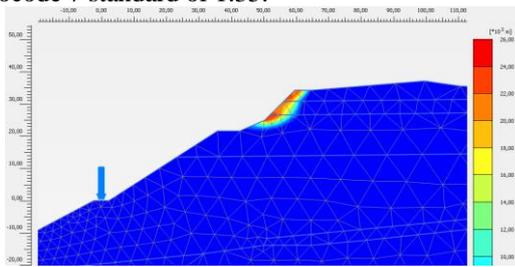
Figure 9. Total displacements in Plaxis – local failure

Due to its calculation method, the Plaxis program always shows the failure method that is most likely to occur sooner. Therefore, the calculation results are greatly influenced by the parameters of the sand layers at the top of the slope. The instantaneous cohesion of these layers depends on the saturation of the layer and the vegetation of the surface. Fig. 9 shows our first results, according to which when the cohesion of the mentioned sand layers is 5 kPa a local erosion is visible. (Fig. 9) In this case, the safety factor is 1.18, thus falling below the Eurocode 7 standard of 1.35.

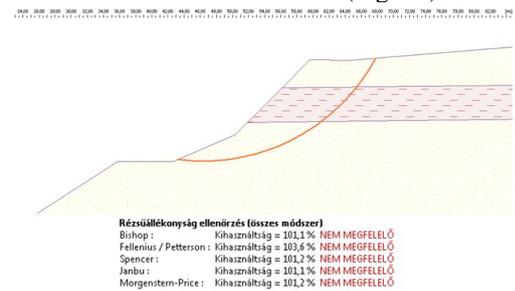
Figure 10. Local slope stability test in Geo5

Taking into account the same soil physics parameters, with the minimum 10% saturation Geo5 software already shown utilization rate above 100%. (Fig. 10)

It can thus be seen that local erosion is most likely to occur. Although these can happen at any time, and there have been several examples before, the signs of local movements can be seen in Fig. 11.

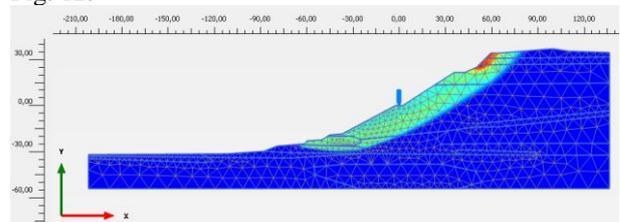
Figure 12. Total displacements in Plaxis – local and global failure

When the cohesion of the upper sand layers reaches 8 kPa, a global slip surface is also drawn. This is shown in Fig. 12.

The factor of safety that can be assigned to this state is 1.29, so it does not reach the level given by Eurocode 7 standard, 1.35. Geo5's classic methods show adequate utilization close to 100%, except for one method (Fig. 13). This exception is according to Fellenius and Petterson; the slope is not stable in this case, and the utilization is 104%.

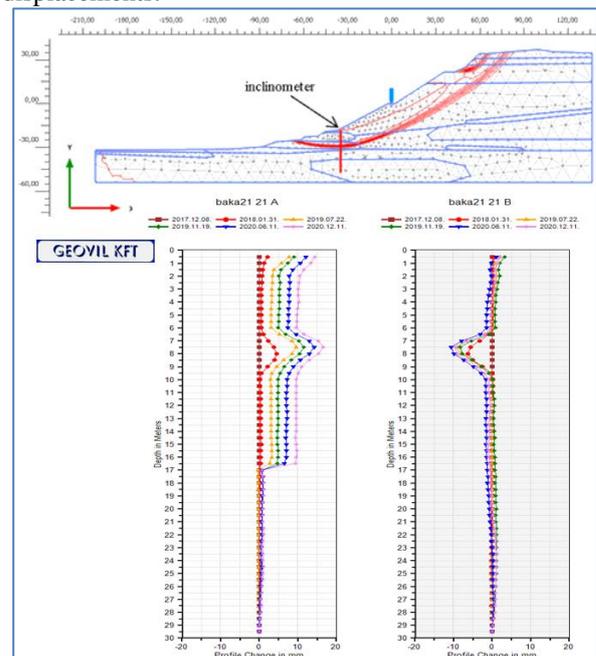
Figure 14. Inclinometer measurement (Geovil Ltd.)

Fig. 14. shows the calculated local and global slip surfaces and the position of an inclinometer measuring well. The displacement curves calculated from the inclination values measured in the 30 meters deep well every half meter for the period 2017-2020 mark these displacements.

The positive (right) displacements in the A axis (left side) means sloping displacements. The B axis closes 90 degrees clockwise with the A axis.

The inclinometer curves show a displacement roughly in the zone where the sliding surface identified from our calculations is also visible. At a depth of 7-8 meters, the boreholes did identify a weak layer, but the displacements of a few mm measured in it have not increased for quite two years now. However, at a depth of 17 m, deeper than the identified slides, there is a slow increase in displacement. It seems a very slow (~16mm/3 years) natural movement. Our recent studies have also shown large curved deep-seated sliding surfaces. [26] Movements appear delayed on the surface, and measurements are frequent enough to identify any accelerating motion in time. However, the curves are also influenced by a number of technical factors.
