On-site Monitoring Surveys and Investigations of Subsurface Cavity for Effective Road Cave-in Prevention

Keywords: road cave-in, cavity, sandy ground, radar exploration, sewer pipe

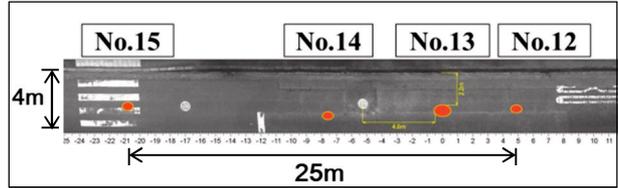
Figure 6. Cavity location map of CASE A taken by the cavity exploration vehicle (red points are cavity).

Fig. 6 shows an example of a high-frequency cavity occurrence road section (hereinafter called "CASE A") using a road surface image taken by the line scanning camera of the cavity exploration vehicle. 4 cavities were confirmed within 25m. Fig.7 shows the size of a cavity; length, width, thickness, and depth.
