Qualitative analysis by local ground water level observations and seepage analysis of underseepage during flood at the Kita river

ABSTRACT: At the Kita River, which flows through Kyushu, Japan, there have been three major floods between 2016 and 2018 that significantly exceeded the height of the ground level. Each time, large-scale sand boils due to underseepage have been confirmed at around 13.0 km on the left bank. The base ground has a very thick permeable layer of gravel. Also, a sand layer (thickness of about 2m) has been distributed near the surface of the ground. Given this, the following mechanism may be in operation. While river water has penetrated into the permeable layer, it has been pressurized by the presence of the sand layer near the surface. It is assumed that the pressurized water has broken up the sand layer locally, causing an outflow at high velocity, which has ejected a large amount of sand. After the 2016 flood, an impervious sheet pile wall had been installed. While the effectiveness of the wall was confirmed in some places. But in other hands, there were some places where seepage and boils still occurred at floods after installing the wall. Ground water le

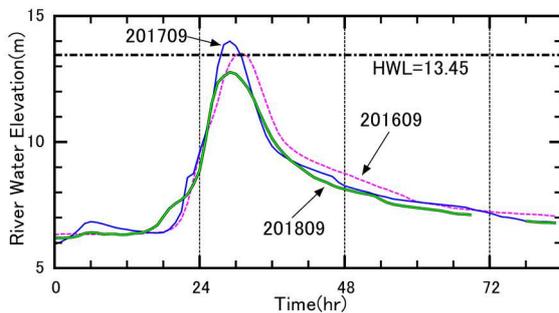
Figure 3. Time history of river water level during floods

There were three floods exceeding the ground level during the three years from 2016 to 2018, and in all of these cases significant water leakage was confirmed. Fig. 3. shows the water level waveform at the time of flooding as observed at the Nagai observatory. These are arranged to exceed the typical ground level of 10 m at around 24 hours. The highest water levels were in the order of 2017(highest water level of 14.2 m), 2016 (highest water level of 13.8 m) and 2018. Those in 2016 and 2017 exceeded the high water level (HWL) of 13.45 m.

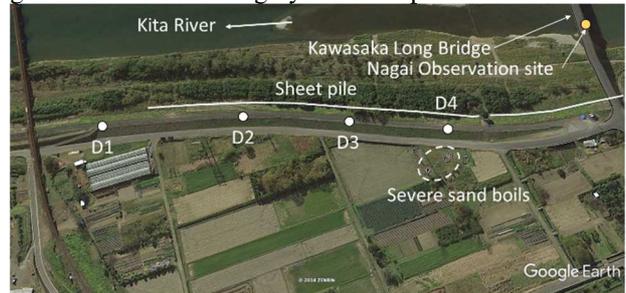
Figure 10. Ground water level observation sites (D1 to D4) and locations of seepage and sand boiling

Observation holes were installed in 4 locations as shown in Fig. 10. to measure the gravel layer pressure distribution directly under embankments at the locations of large-scale seepage and sand boiling and their surrounds.

D1 is very dense. When setting the placement of the impervious sheet piles it was not known that there was a change in gravel layer properties between D1 and D2, but this change in gravel layer density happened to be in the location where the impervious sheet piles were laid. The most upstream point of D4 was the closest to the location of large-scale seepage and sand boiling.

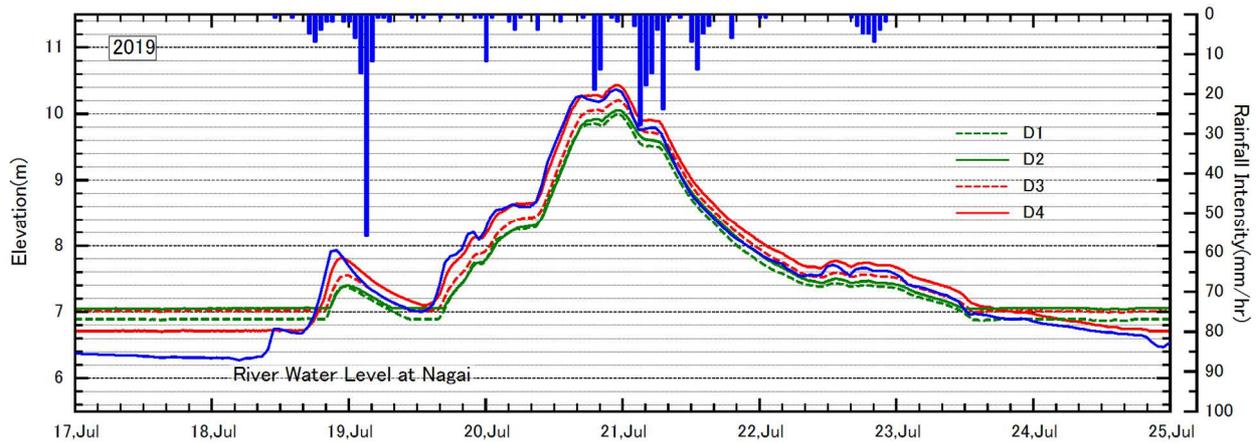
Figure 11. Observation results during July 2019 medium-scale flooding

In July and August 2019 there were medium-scale floods slightly above the ground level. Fig. 11. and 12. show the combined river water level and precipitation at the time as observed from the observation holes and at Nagai observatory.

In the July flood, the small peak was reached from the rain on the afternoon of the 18th. At this time, the water level in the borehole also peaked, with a time delay of 1 or 2 hours. The peak borehole water level was of an order that was close to the location of the large-scale seepage and sand boiling, but both were lower than the river water level, and it was assumed that the borehole water level changed due to pressure propagation due to river water levels. After this, the river water level rose significantly, peaking from the night of the 20th to the early morning of the 21st. At this time, D4 and the river water level rose about the same amount. While this is thought to be dominated by pressure propagation from the river, the rise to the same height as the river water level cannot be completely explained by pressure propagation from the river. Other factors could be thought to include ground water supply from the land sides. Prior to the rain on the 18th, there had been no rain for five days, so the ground water supply had been decreasing, suggesting that pressure propagation from the river had become dominant. Until the peak on the 20th, there was an increase in ground water supply due to rainfall on the 18th and 19th, and this may have led to the river water level being the same as the observation hole water level.

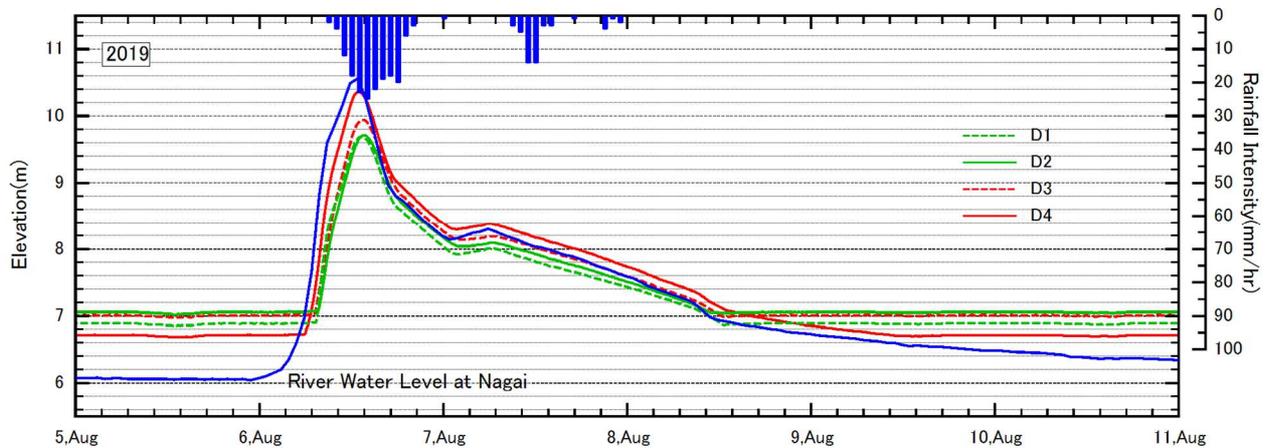
Figure 12. Observation results during August 2019 medium-scale flooding

A similar waveform can be observed to the July 18 night peak in the August flood. There was no rain over

the five days from August 1 through 5, and the ground water supply conditions are assumed to have been very similar to those of the night of July 18.

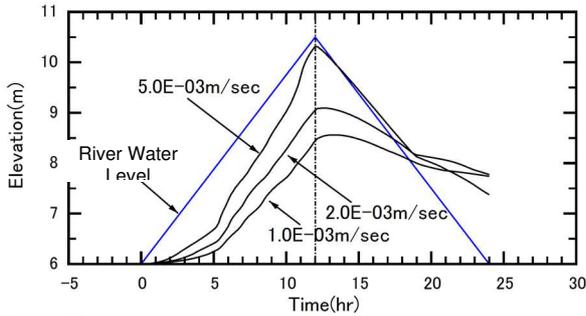
Figure 15. Changes in response due to differences in ground base coefficient of permeability

Fig. 15. shows the application of multiplying the gravel layer with the permeability of 1.0E-03m/sec, 2.0E-03m/sec and 5.0E-03m/sec. The permeability of 1.0E-03m/sec was obtained from the in-situ permeability test. According to these results, the speed of water level reduction was slow compared to actual results for the values of 1.0E-03m/sec and 2.0E-03m/sec, while 5.0E-3m/sec result showed the closest to actual behavior. Thus, in the following calculations the figure of 5.0E-03 m/sec is used for the permeability of the gravel layer. This value

also obtained a maximum borehole water level closest to actual values.

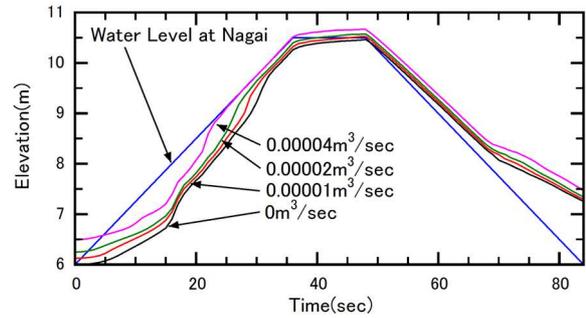
Figure 16. Changes in response due to differences in ground water supply

As a result, the borehole water level was considerably low with respect to the river water level and differed from observed results. Then, a source of current was applied to 5 nodes located at the border with the impermeable layer below the viscous soil on the land side. The amount of

current from each node was of three types, 0.00001 m³/sec, 0.00002 m³/sec and 0.00004 m³/sec. These results are shown in Fig. 16. By applying a current of 0.00004 m³/sec, the borehole water level was confirmed to reach the same height as the river water level.

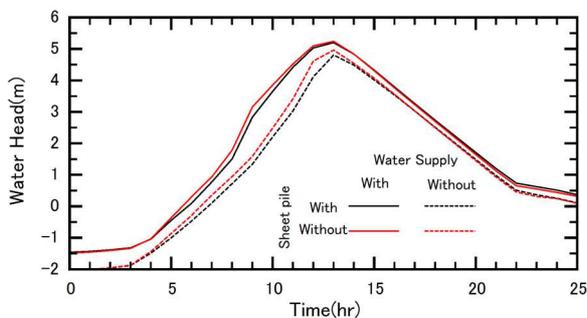
Figure 17. Slope foot base ground pressure head

Fig. 17. shows the nodal pressure head time series at the location of the border of the sand and gravel layers directly under the slope foot. It was found that the results changed a relatively large amount depending on the presence of ground water supply, regardless of the presence of impervious sheet piles. Viewed from the land side, impervious sheet piles appear to artificially create a dead end, but according to the results of the seepage analysis there was no impact. However, when viewed from the opposite perspective, it can also be said that when there is a ground water supply the effect of the impervious sheet pile does not appear. The original effect of impervious sheet pile was not leakage control but the suppression of piping formed directly below the embankment. Therefore, it can be considered that the effect of the impervious sheet pile should not be evaluated based on a single point of pressure directly below the slope foot, but based on the pressure distribution directly under the embankment.
