# Investigation on Slope Failures Caused by the 2018 Northern Kyushu Torrential Rainfall, Japan

**ABSTRACT:** During June 28 to July 8, 2018 torrential rainfalls in most parts of Japan caused many slope failures and debris flows. In order to protect the lives and properties of residents from disastrous slope disasters, it is necessary to evaluate the risk of slope failures and to clarify the mechanism of failures to arrive at efficient and effective disaster prevention measures. This study covers the slopes that failed in Kitakyushu city, that composed of complex geological structures, during the July 2018 western Japan torrential rainfall. Through detailed investigations of the topography and geological conditions, the cause of such slope failures was ascertained. The investigations were conducted using both the topographical observation and UAV survey. Based on the investigation results, the mechanism of the slope failure was elucidated, and design procedures for the recovery countermeasures were arrived at.

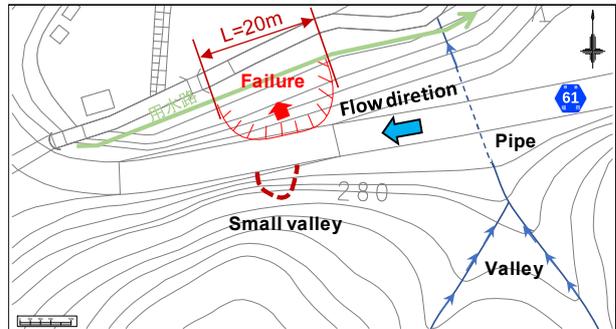
Figure 10. Topographic map around the failure slope [7]

The topography of the slope failed land is a parallel slope on the side of the ridge topography and does not show a typical water collection topography. The slope on the mountain side of the road is an untreated cut slope, and a part of the slope failed horseshoe-shaped depression (valley-like landform) is seen.

Slope failure has occurred in embankments and cliff deposits. On the left side of the landslide slope, erosion marks due to water leakage from the broken road gutter are seen.

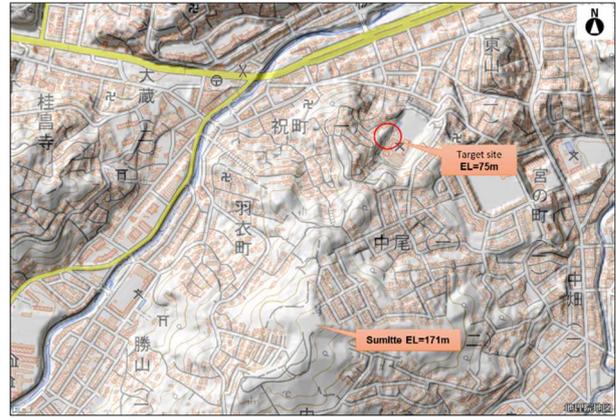
Figure 13. The topographic map around the failure slope [5]

Fig. 13 shows the topographic map around the target site, Fig. 14 shows the aerial photograph, and Fig. 15 shows the photograph and sketch of the failure slope. The failure slope is located in a low mountainous area with small undulations where residential land development has progressed, and on a straight ridge topography. In the borehole survey, fresh rock mass has not been confirmed, and there is no outcrop nearby, so the relationship between geological structure and topography and failure is unknown. Since it is located on the east side of the ridge topography and surface water is not easily collected, it is thought that the influence of surface water on the collapse is small.

The geology of the failure slope is composed of strongly weathered sandstone corresponding to the Lower Cretaceous Kanmon Group and the Shimonoseki Group, and exhibits a reddish brown to yellow-gray sandy cohesive soil. As a result of the survey, weathering progressed at a thickness of 10 m or more (Fig. 16).
