Application of CPT to investigation of abandoned shallow coal workings, and their remediation by grouting

ABSTRACT: CPT testing was carried out before and after the grouting of abandoned shallow coal mine workings to understand the conditions of the workings and to infer the extent of underground voids that were filled with grout during their remediation. The site, with 2-3m of coal extracted by bord and pillar workings from between 10 and 13m depth, has a recorded history of widespread surface subsidence and ongoing potholing over the more than 100 year period since mining ceased. Prior to grouting, from 3 CPTs and three drilled boreholes, there was no evidence of open voids, indicating that collapse of the workings was extensive. The CPT was found to be a poor differentiator of subsurface conditions in this instance, failing to clearly differentiate intact roof from subsided roof, or between subsided roof and goaf. Despite the phreatic surface lying only 4-6m below the surface, pore water pressure data was inconsistent, fluctuating unpredictably between positive and negative values. Generally, negative pore pressures were recorded at depths corresponding to the subsided roof and

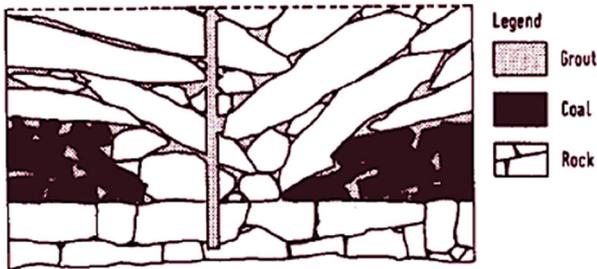
Grouting is typically achieved by drilling a grid of closely spaced boreholes (4-5m) to below the level of the mine workings and pumping grout into the workings at floor level via a tremie line. Verification is usually done by drilling randomly-selected verification boreholes to assess the effectiveness of the remediation program. An idealized section, showing a site remediated via grouting of shallow collapsed mine workings is shown in Figure 3.

Figure 3. Idealised section of grouted zone in collapsed workings (Healy and Head (1988), after Littlejohn (1979)).

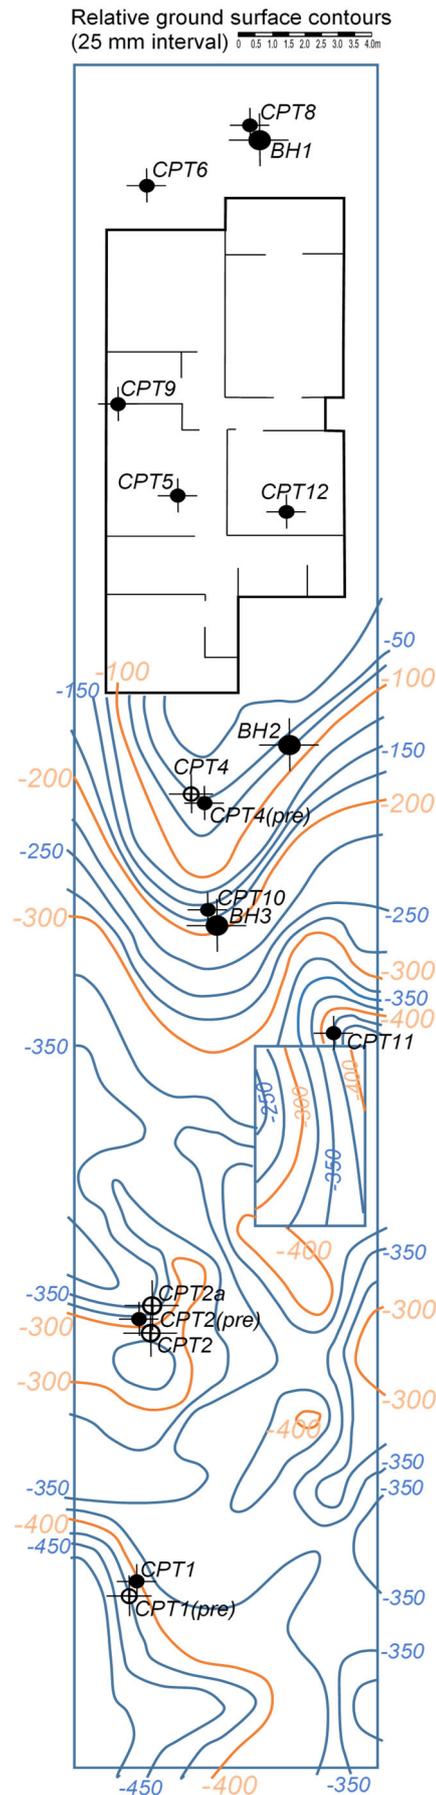
The layout of CPT tests is shown in Figure 7, relative to the position of the (former) house on the site. The positions of drilled site investigation boreholes (including BH1; see Figure 4) are also shown.

Figure 7. Site map showing the location of the house (prior to demolition) and the test locations. The contours show relative ground surface levels (in mm) prior to the site being regraded.
