Soil investigations and soil tests required for seismic inspection of abandoned tailings dams in Japan

S. Yasuda

ABSTRACT: Japan has mined many metals for centuries. Most of the mines has been closed due to the low total amount of ore deposits, leaving many abandoned tailings dams. Japan compiled its first design code for tailings dams in 1954. A tailings dam damaged due to the liquefaction of tailings materials in the 1978 Izuoshima-kinkai Earthquake. After the earthquake, many cyclic triaxial tests were conducted to study the liquefaction strength of the tailings. Based on the results, the code was revised in 1980. The existing tailings dams were examined and strengthened if needed, in accordance with the reviced code. Despite these inspections, three tailings dams failed during the 2011 Great East Japan Earthquake. The main reason for the failures was strong shaking. Based on detailed investigations, the seismic design code was revised again in 2012 to ensure the stability of tailings dams during strong earthquake motion. Failures of tailings dams during past earthquakes, the history of the revisions of seismic design code and examples of soil investigations, soil tests and an

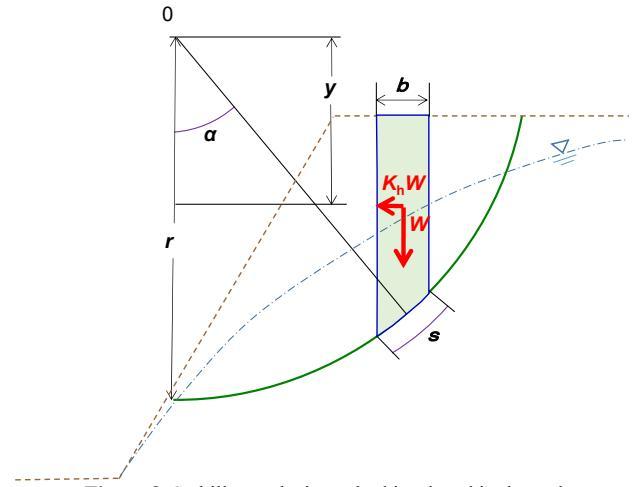
The code requires that a stability analysis of each dam be conducted assuming a circular slip surface as shown in Fig. 8. The pressure U_L is applied to the sliding surface of each slice according to the following formula:

Figure 8. Stability analysis method intrduced in the code

Existing tailings dams were examined for seismic safety in accordace with the revised code and were strengthened to increase their safety as needed.

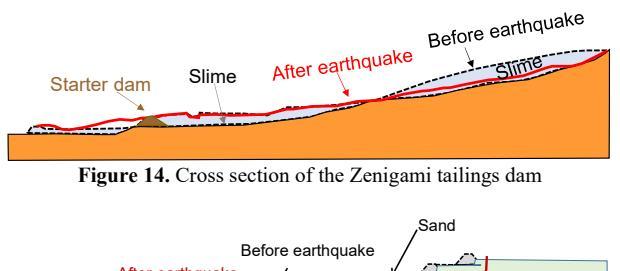
Figs. 13 and 14 show the failed slope and its cross section of the Zenigami tailings dam at the Takatama Mine, respectively. The dam was constructed by the inner filling method by pasting slime. No sand volcano was observed on the failed slope. Based on detailed soil tests and analyses, it was concluded that the tailings in the upper slope of the dam failed, as shown in Fig. 13, and flowed over a road and into a river. The road was temporarily closed. In the restoration work, a new starter dam was constructed slightly higher than the existing starter dam. The failed tailings were then filled behind the new starter dam at a gentle slope to prevent sliding failure in the future earthquakes. A counterweight fill was heaped on the downstream slope of the existing starter dam to prevent sliding during earthquakes.

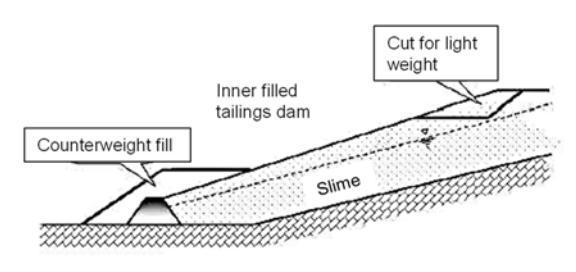
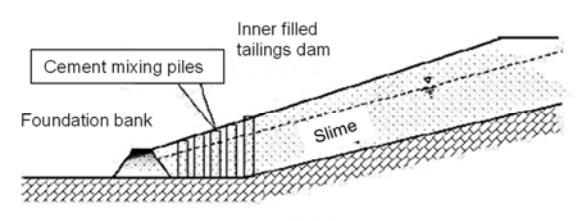
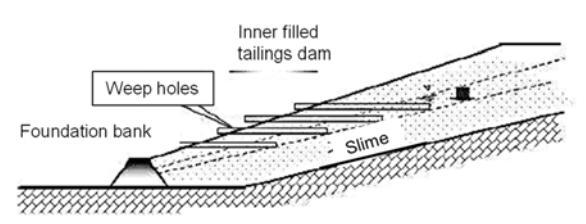
(3) Weeping and groundwater lowering method Figure 16. Appropriate measures to counter the deformation of

tailings dams

This new design concept, a so called performancebased design, is rational. In performance-based design, two items must be decided: 1) the allowable deformation or displacement of embankments, and 2) the relevant method to estimate the deformation. After the Kobe Earthquake, three methods of estimating deformation were developed for water reservoir dams, river dikes, road embankments and railway embankments: empirical methods, static (residual deformation) analyses and dynamic (seismic response) analyses. It was recommended that these new techniques be applied in the inspection of tailings dams deemed susceptible to failure. The allowable deformation of these dams must be judged as unlikely to cause serious damage to structures, such as houses, if the dams were deformed. The recommended measures to counter dam deformation are shown in Fig. 16.

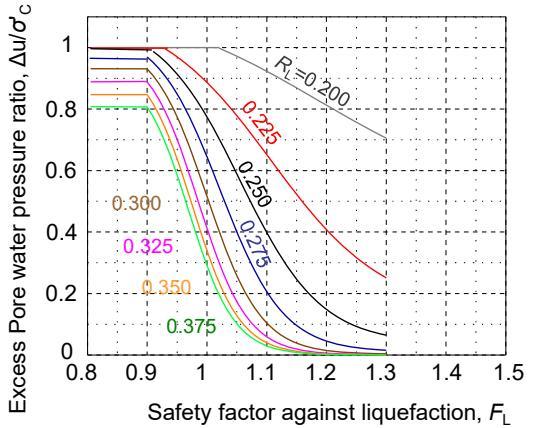
- (3) Step 3: The time history of the distribution of the safety factor against liquefaction, F_L in the section was calculated based on the static and dynamic stresses and on soil strength. Then the time history of the distribution of the excess pore-water pressure was calculated. The relationship between F_L and excess pore-water pressure ratio used in this analysis was not from Eq. (4) but a newly proposed one as shown in Fig.18, derived based on many laboratory tests for liquefaction.

Figure 18. Relationship between $F_{\rm L}$ and excess pore-water pressure ratio used in this analysis

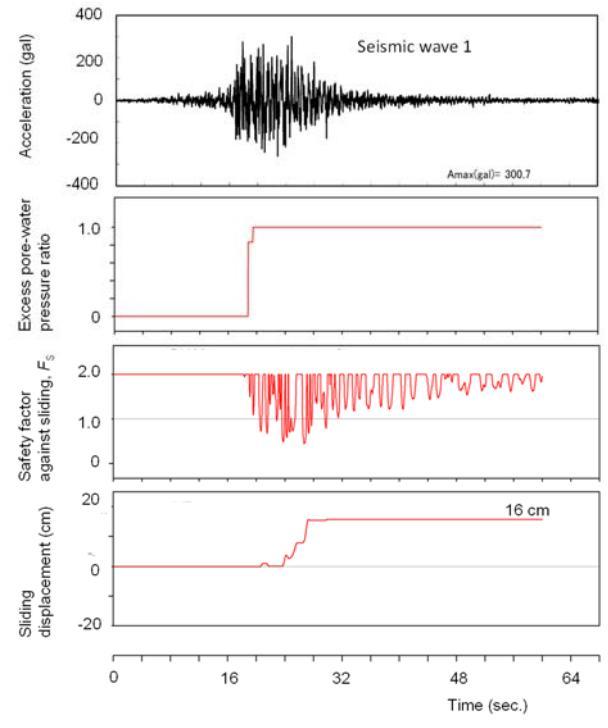
Figure 19 shows the distribution of peak acceleration under seismic wave 1. The peak acceleration increased gradually from the bottom of the slope to about 500 gals (cm/s^2) at the surface of the slope. Figs. 20 and 21 show the distributions of F_L and the excess pore-water pressure ratio, respectively, under seismic wave 1. The shallow parts of tailings slime in upper zone liquefy and the excess pore-water pressure ratio U_L/σ_v reaches 1.0. The liquefied zone is almost the same under the seismic waves 2 and 3. Fig. 22 shows assumed several slip surfaces and sliding displacements along these surfaces under seismic wave 1. The maximum sliding displacement which occurs in upper zone is 16 cm. Fig. 23 shows the time history of the input seismic wave 1, the excess pore-water pressure, the safety factor against sliding, F_S , and the sliding displacement along this sliding surface. The estimated sliding displacement is not large enough to cause flow of the liquefied slime. Therefore it was judged that the tailings dam is stable under Level 2 earthquake motion.

Figure 22. Sliding displacements of the input seismic wave No.1
